## **ANALYSIS AND EXPERIMENTS**

### **Falsification of the hypothesis from Miller and MAK reports concerning the destruction of the entire plane after hitting the ground**

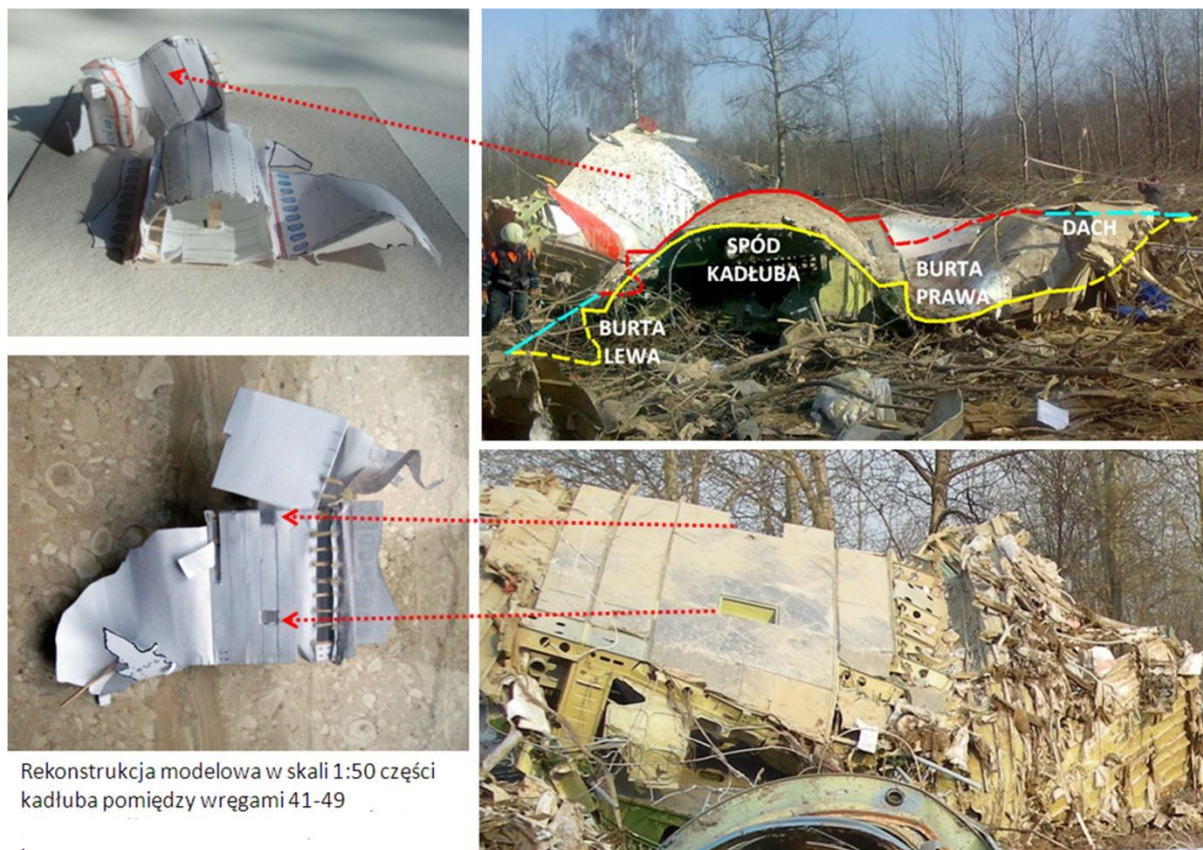
**Fig. 44.** Image of the fuselage destruction with both sides of the fuselage opened and thrown outwards.

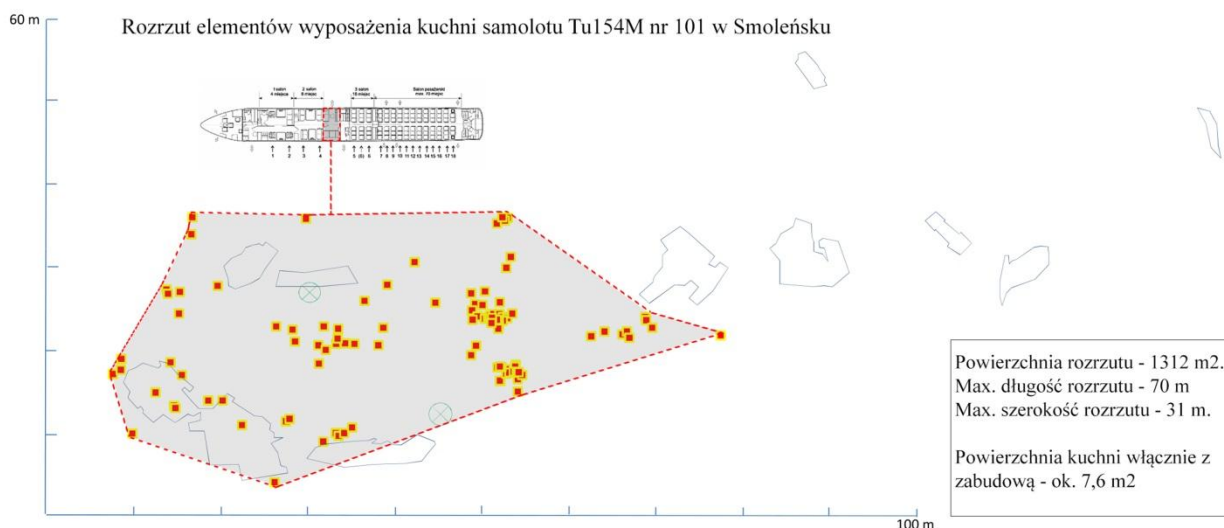
Disintegration of the galley is shown in fig. 45. The smaller than 8m<sup>2</sup> galley area was found scattered over more than 1300m<sup>2</sup> in small fragments.

**Fig.45.** Parts of the galley before the third salon were distributed in the shown region on an area of 1312m<sup>2</sup>.

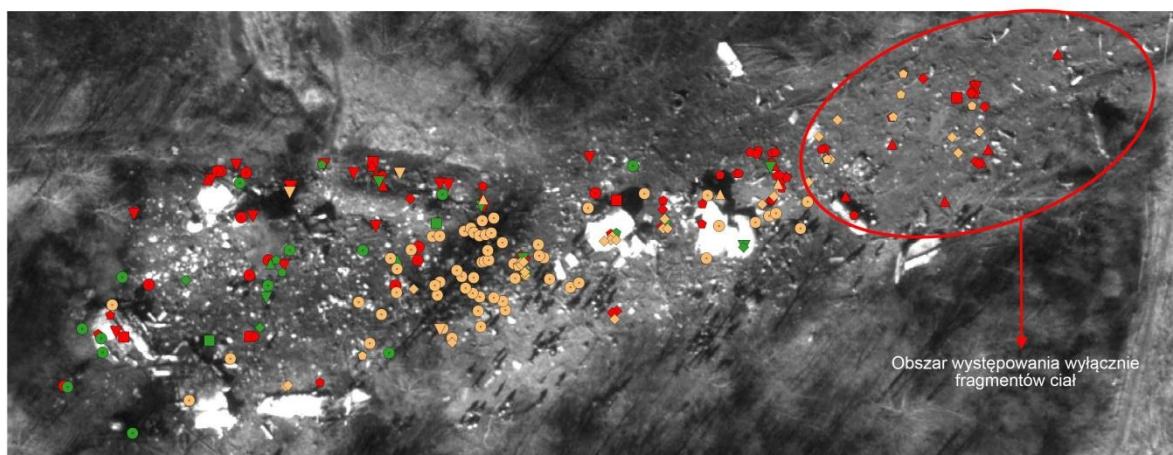
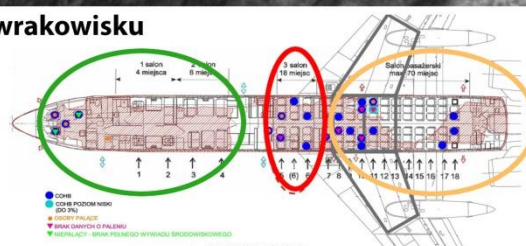
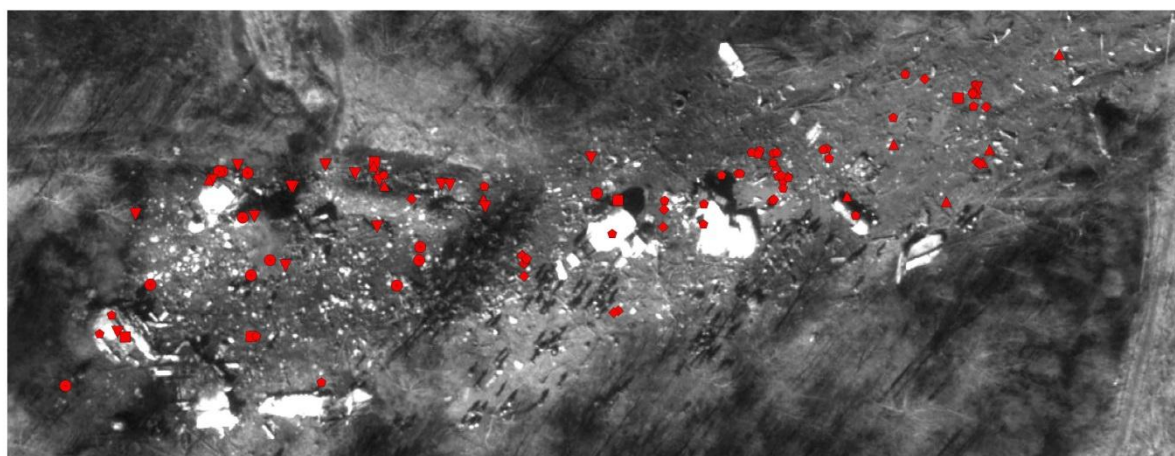
All 96 occupants on board died. All occupants were thrown outside of the fuselage, as were the seats, on which they were sitting, including the floor-covering with insulation. At the beginning of the crash site, apart from pieces of the plane, only small, torn pieces of the bodies of victims were found, and numerous internal organs identified. This shows that even before the plane hit the ground the bodies of the occupants sitting in the center part of the plane (lounge no.3) were damaged and torn into pieces. (Fig. 46).

**Fig.46.** Location of bodies on the crash site. Only small body fragments and intestines were found in the area circled at the top picture, often far from the main body. The fuselage was more than 6m above the ground when passing this area. Whole bodies are marked with a red circle.

Parts of the body were found at the beginning of the crash site, before the fuselage hit the ground. This shows that the movement of the body parts was opposite to the movement of the plane. In all the cases identified these were body parts of people sitting at the front part of the plane, especially in lounge 3. At the same time it is important to say that the door rammed into the ground was found nearby, as well as the galley (distributed on 1/3 of area of the crash site) and the left center wing.

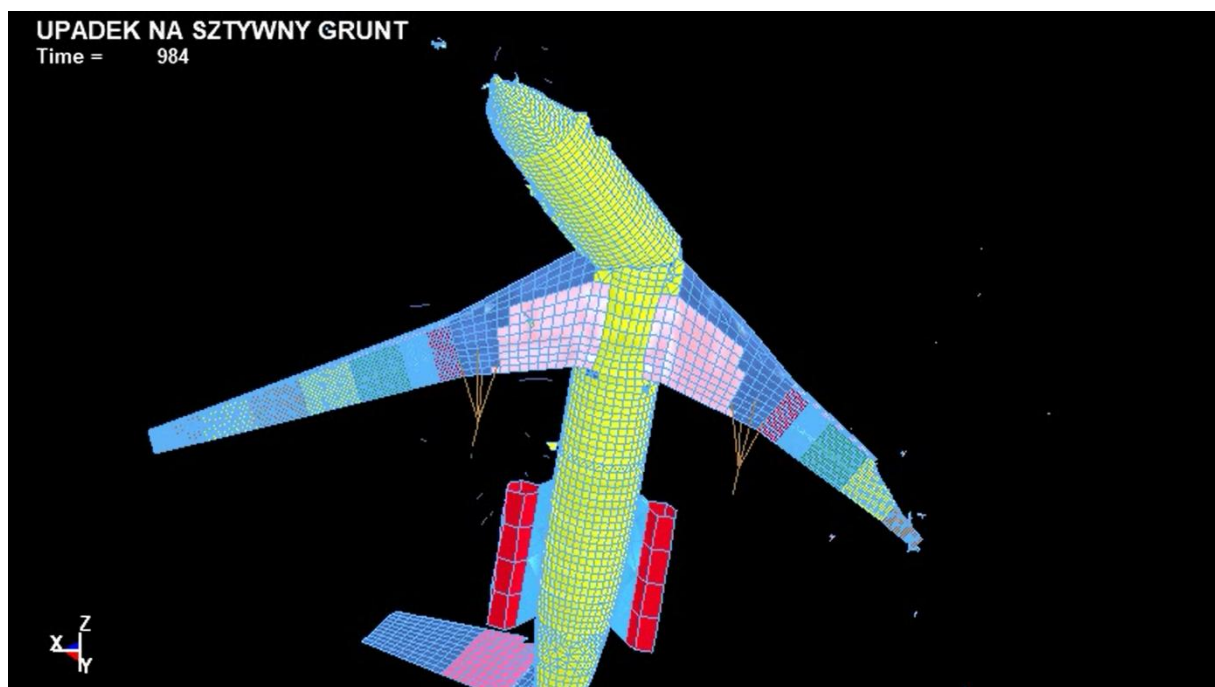
**Rys. 47.** Simulation of the disintegration of an airplane hitting stiff ground (concrete). The aircraft only breaks into a few parts.

1. The simulation of the plane's destruction shows a completely different destruction of the construction than the one found at the crash site.

3. The above-mentioned crash reports assume that the plane, while hitting the ground, should disintegrate into thousands of pieces, according to what was found on the crash site. The results of simulation show clear destructions of the construction; however the plane is still there and not only its scattered segments.

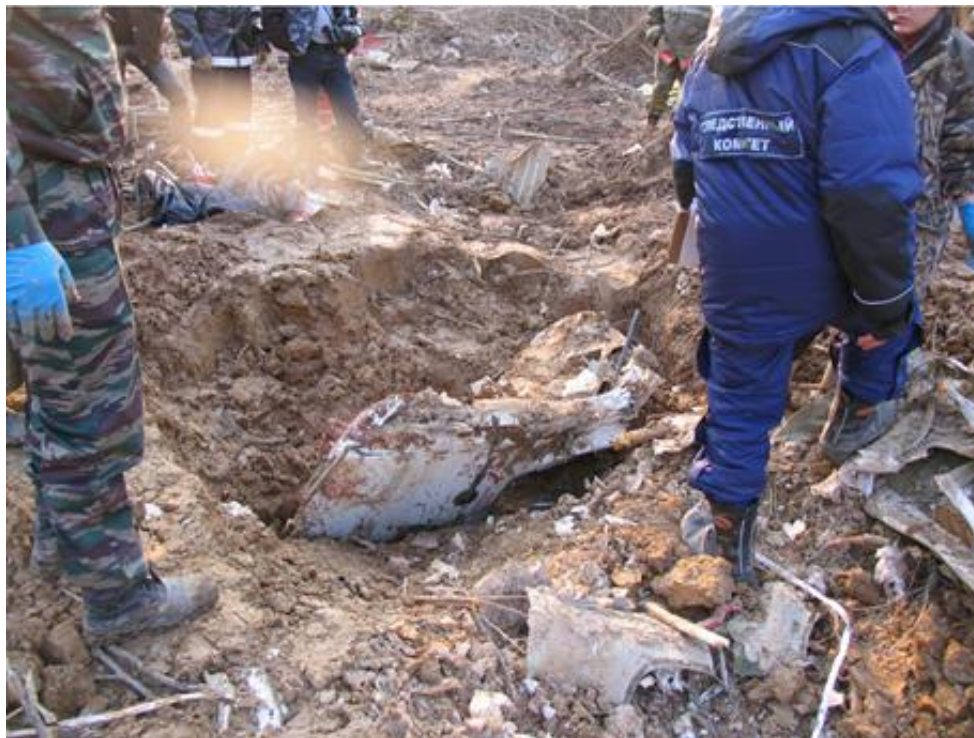
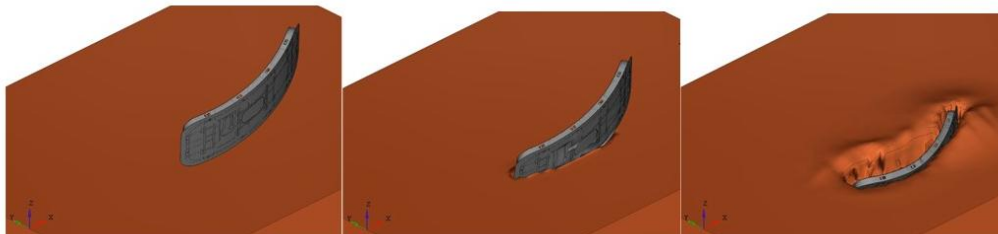
Simulations done by the independent National Institute of Aviation Research (NIAR) in the US show the required vertical speed of the left passenger door was more than  $V_{z\_door} > 120 \text{ m/s}$  in order to produce the observed door damage and full penetration into the ground. (This means the vertical energy of the door when penetrating into the ground was 100 times greater than the kinetic energy it possessed by the vertical velocity of the aircraft)

On the inside of the left passenger door No. 2 (No. 823) numerous cracks in the aluminum cover can be seen. Such cracks should not be generated during the flight.

Figure 48 Shows results from NIAR's simulation of the door hitting soft ground and the door buried 1meter in the ground as Russians were digging it out by hand.

When pulling the left passenger door 2L, driven over 1m into the ground, a human hand and forearm were found near the door handle. Source: Images of the door driven into the ground

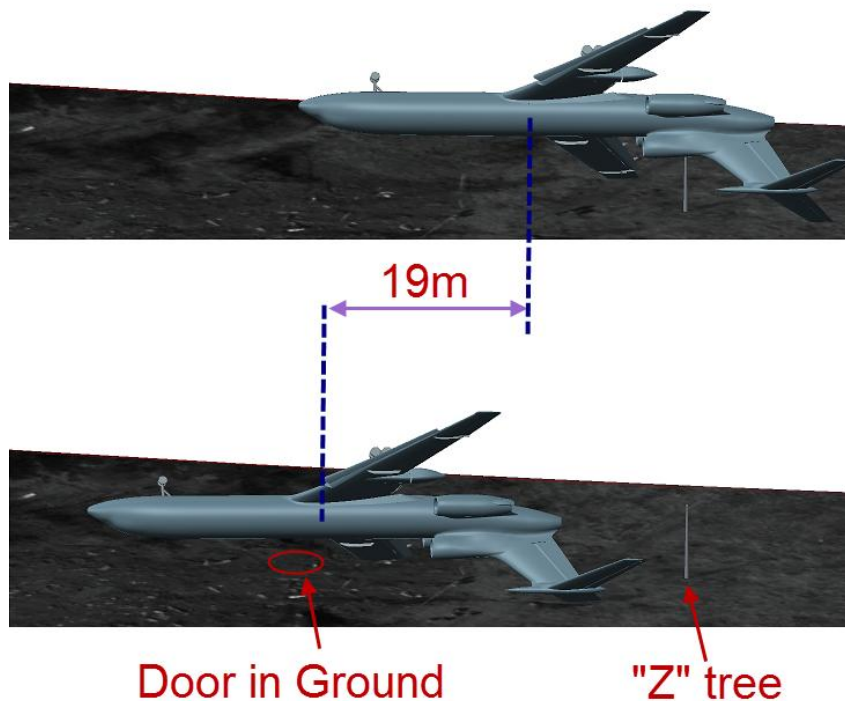
**Fig. 49.** The position of the plane the moment it passes the Z tree and the position of the plane above the rammed door.

The distance between the trees west of the street and the tree marked "Z" is about 103m and the time it takes to travel this distance can be worked out as  $\Delta t = 103\text{m}/75\text{m/s} = 1.37\text{s}$

The vertical velocity by this method works out as  $\Delta H/\Delta t = (25\text{m}-10\text{m})/1.37\text{s} = 15\text{m}/1.37\text{s} = 11\text{m/s}$

The minimum height 19m after passing the tree marked "Z" works out as  $(10\text{m} - 19\text{m}/103\text{m} \cdot 15\text{m}) = 7\text{m}$

This is the height of the center of gravity of the aircraft at the moment the aircraft is above the position where the door was found buried 1m into the ground.

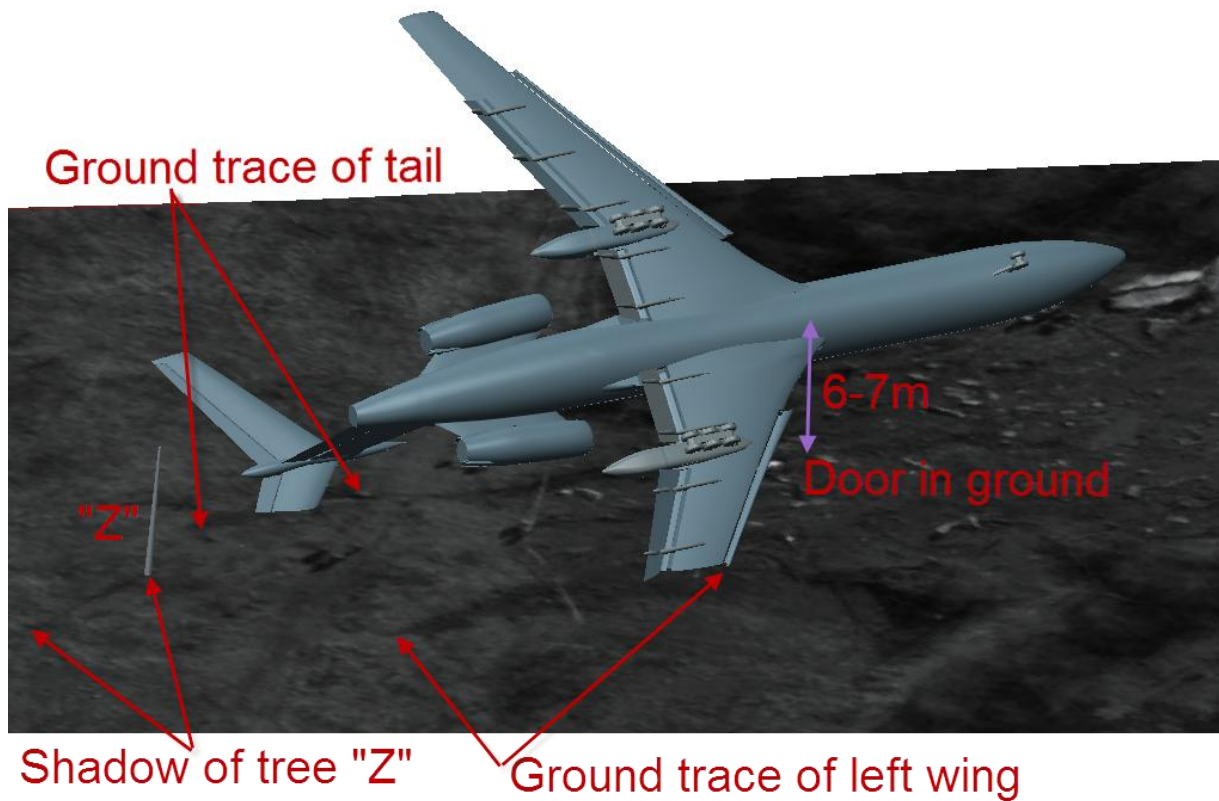
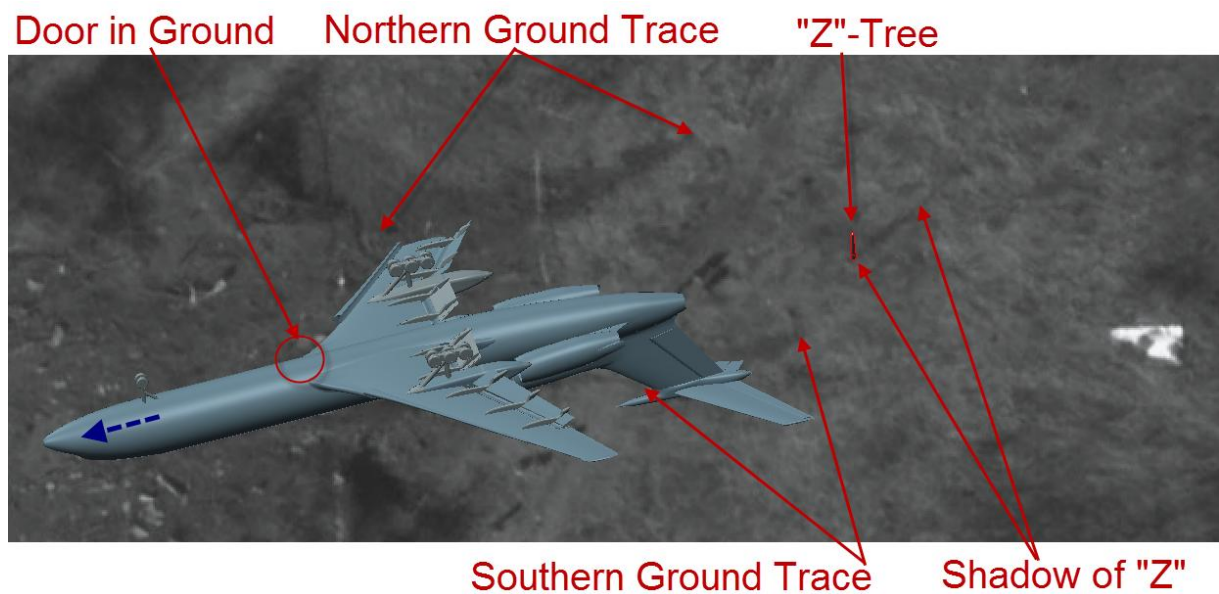
Pic.50. The moment the plane hit the ground

Analysis of the ground traces assumes the left roll of the aircraft to be about 130° when the remains of the left wing touched the ground at the beginning of the main crash site. They assume the height above the ground was about 6-7m when the fuselage was positioned with the left passenger door above the location it was in the ground.

The ground traces of wing come to a stop at the moment the fuselage was above the position of the door in the ground, and from this point the aircraft was found scattered into thousands of pieces without creating a crater.

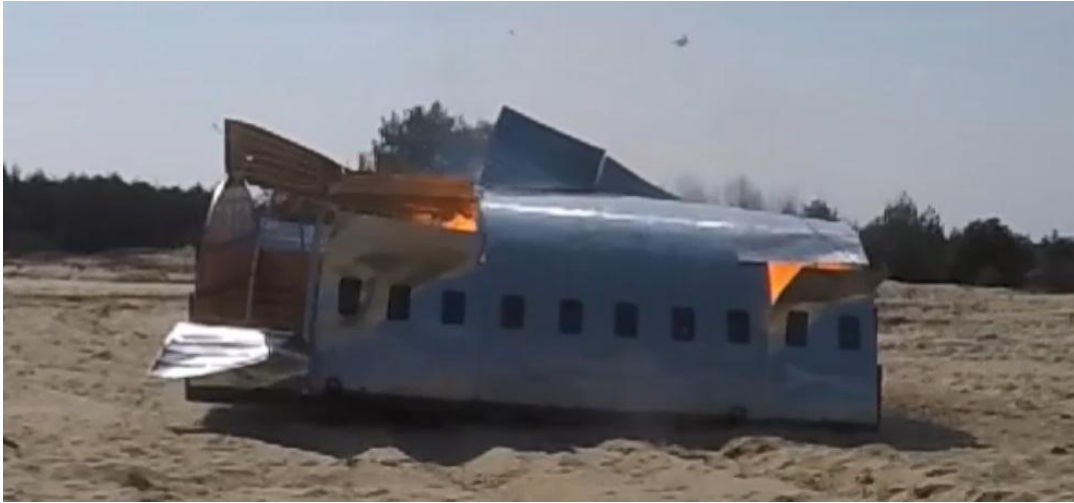
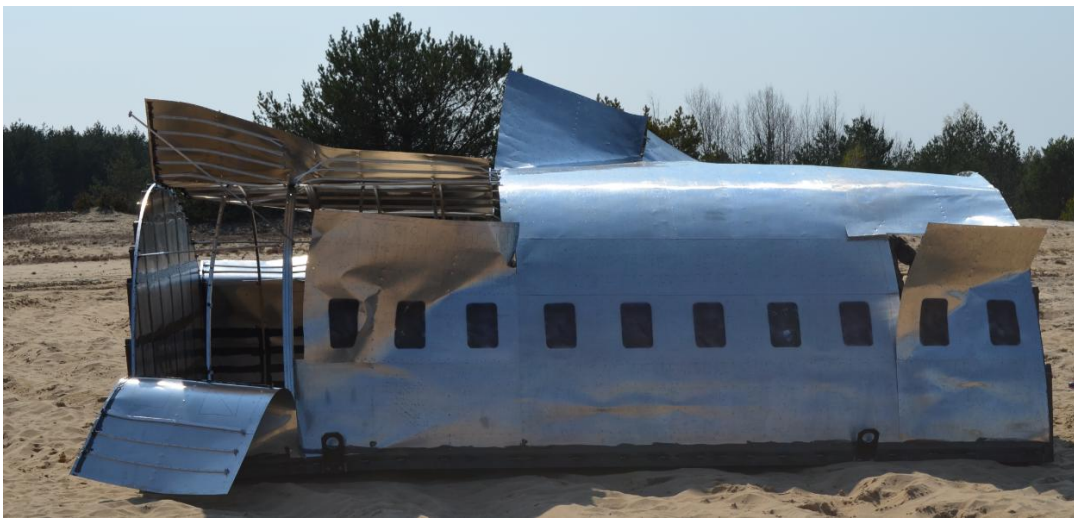
Experiments carried out by the Committee on a model of the occupants part of TU154M on a 1:1 scale show that the destruction of the plane observed in Smolensk could not be the result of a fuel explosion. (Fig. 51).

**Fig.51.** Explosion of jet-fuel in the occupant's part of the fuselage resulting in a large opening but not resulting in destruction into small pieces.

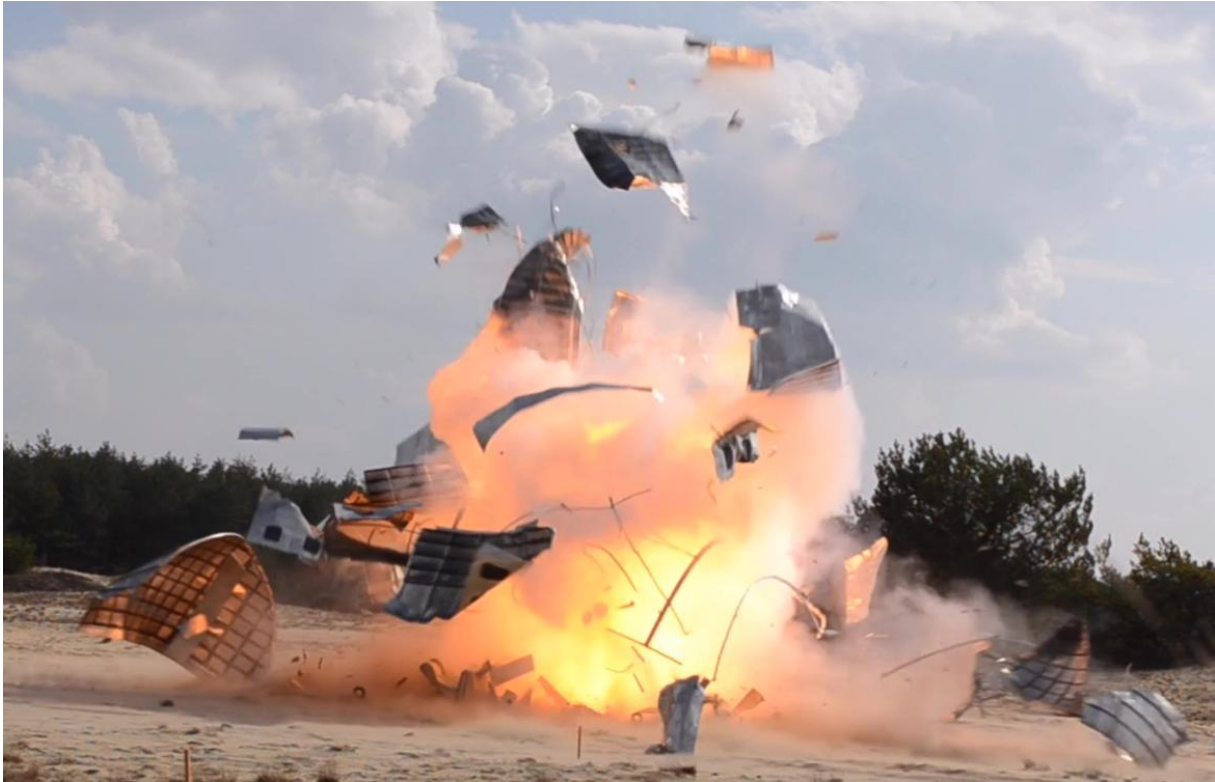
Experiments conducted by the Committee on a model 1:1 of the occupant's part show that such disintegration, as observed in Smolensk, can be the effect of one or many detonations of air-fuel charges, with special consideration given to a thermo-baric charge with a longer tension impulse propagated inside the fuselage before hitting the ground. (Fig. 52).

**Fig. 52.** Explosion of a thermo-baric charge in the occupant's part of the fuselage resulting in the complete destruction of the fuselage and the formation of a lot of small debris.

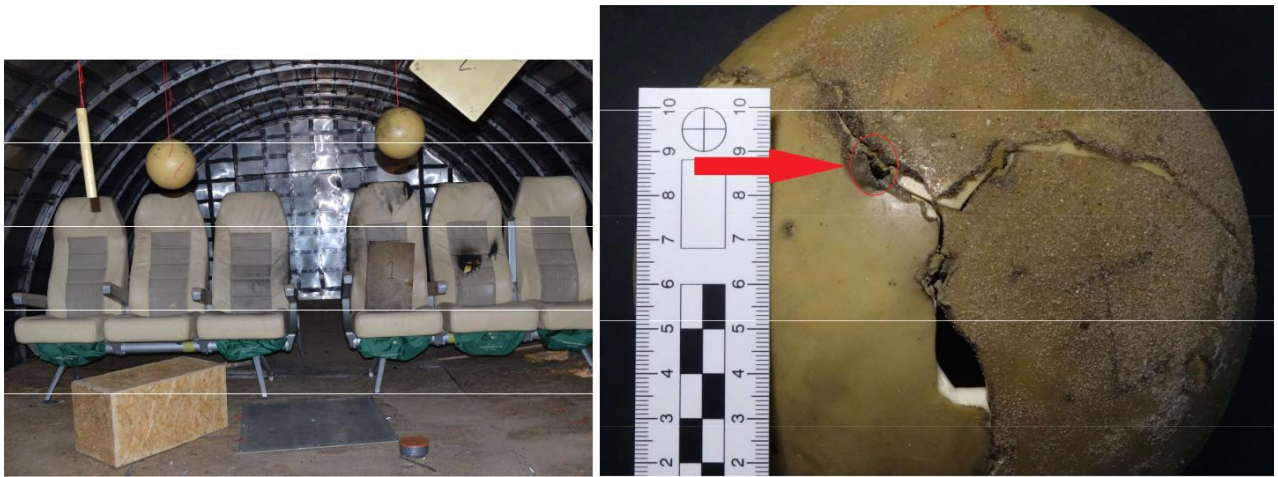
Fig. 53 Medical phantoms inside the model of the occupants part of the plane
