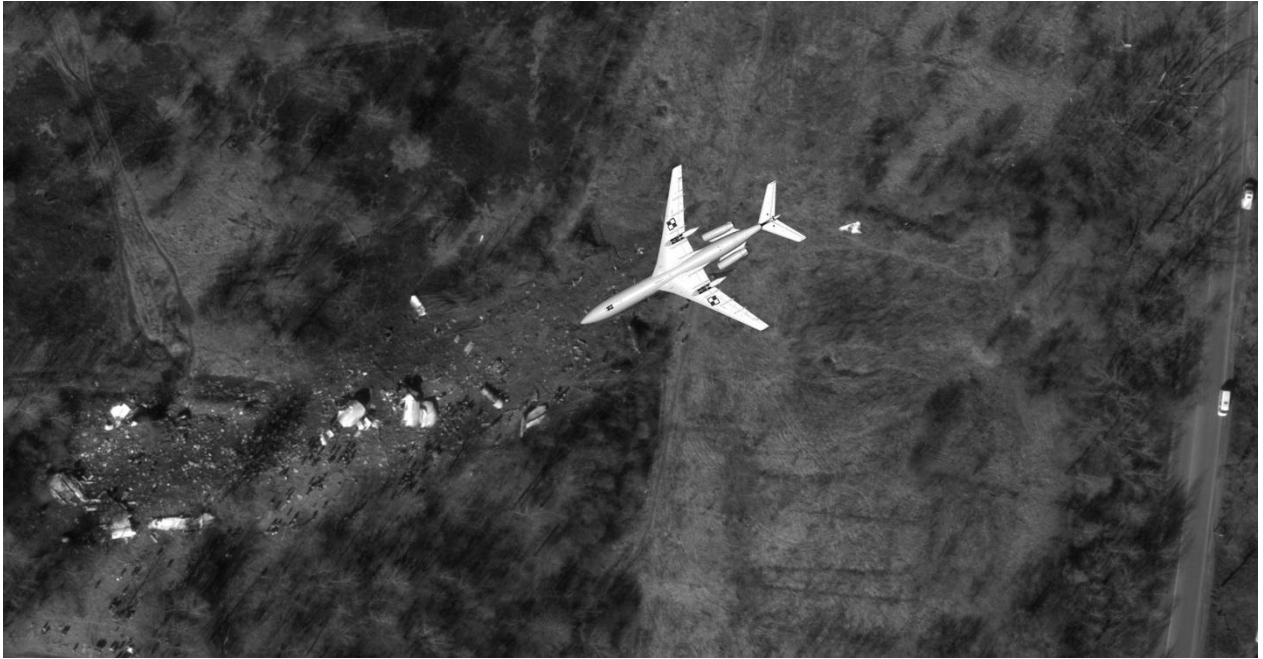
Fig. 35. A general view of the crash site compared to TU154M in a reverse position, in the correct scale.

The top down view of the main crash site shows the characteristic positioning of trees in its initial part- from the northern part to the front, in accordance with the flight path, and from the south to the back. This fact points to an active blast wave.

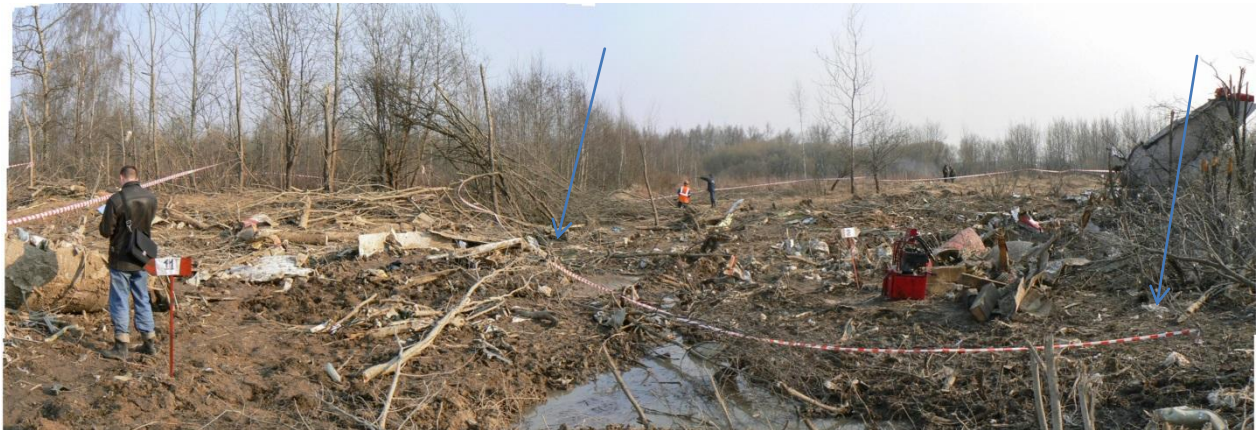
Fig. 36. A picture of the main crash site.

An explosion in the left part of the center wing caused the destruction of the majority of the outer skin, ribs and spar no.1 of the fuel box no.4. Those elements of the plane on the main crash site (Fig. 36) have clear shear marks and visible effects of the blast wave being the result of an explosion. The pictures below reconstruct the mechanism and scale of destruction of the left center wing.

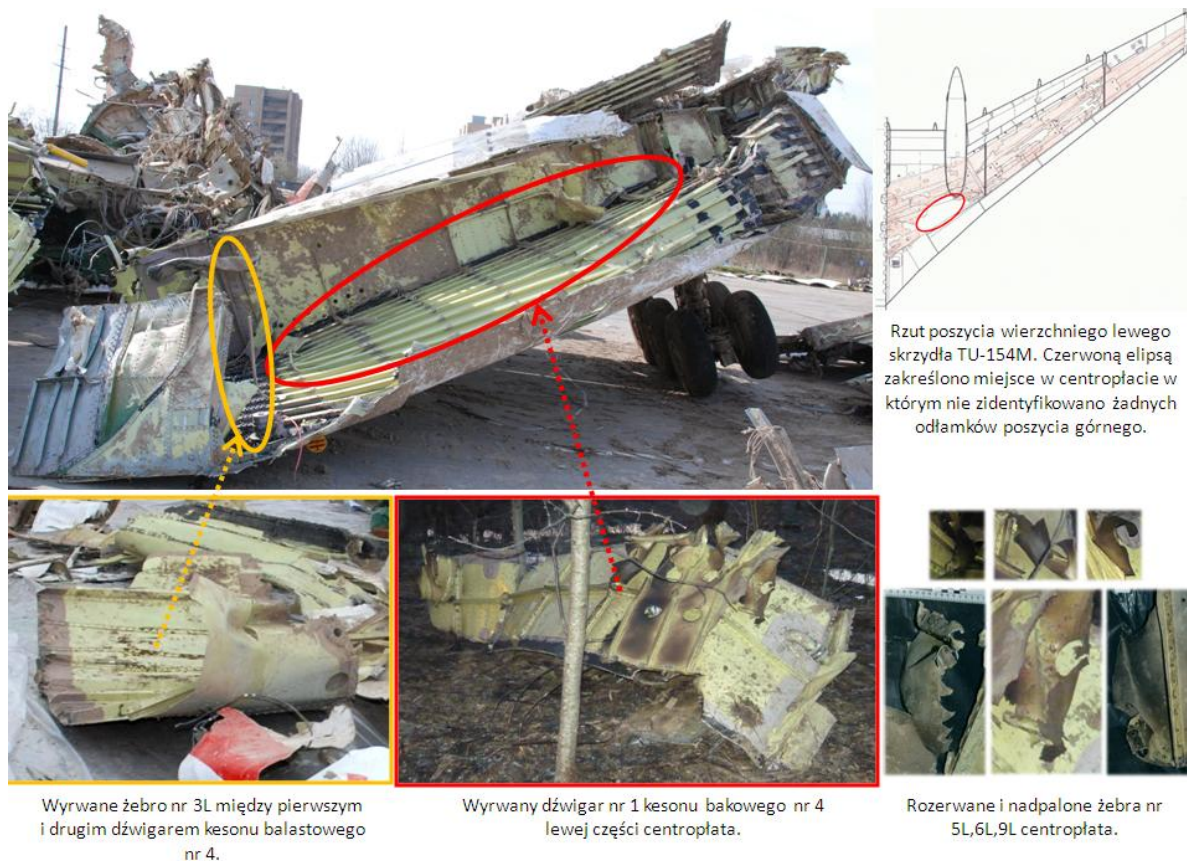
Fig. 37. Note the ripped spar no.1 of the fuel box no.4 of the left part of the center wing with clear signs of high temperature and destruction of burned ribs visible on the right side of the picture. Other parts from this area found outside the fire zones were also found with similar signs.

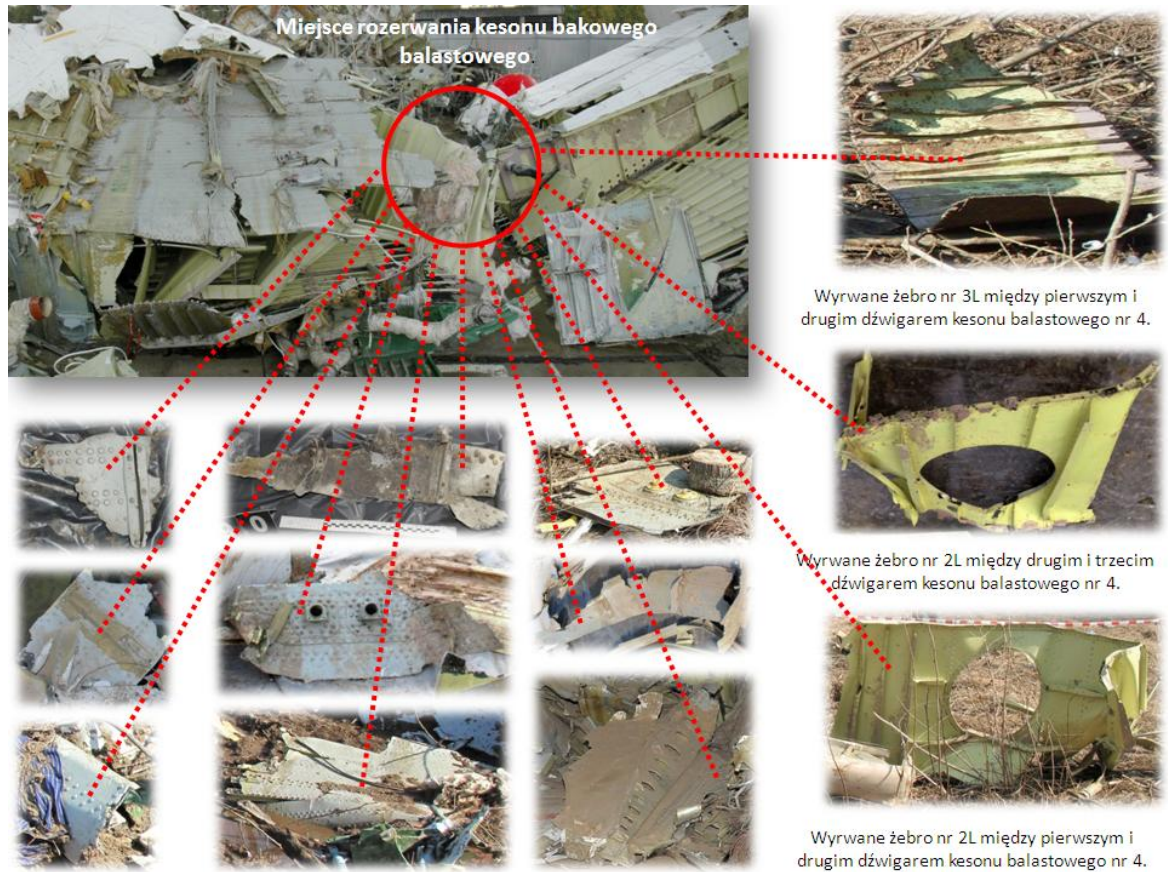
The tearing and the destruction of the fuel box could not have been a result of a hydraulic impact, caused by the impact with the ground, especially looking at the small amount of fuel and limited space. One has to consider the elements of the skin, ribs, rear spar, which were torn off, most likely due to high internal pressure. (Fig. 38 and fig. 40).

Fig. 38a. Place of the destruction of the ballast box and the destroyed elements.

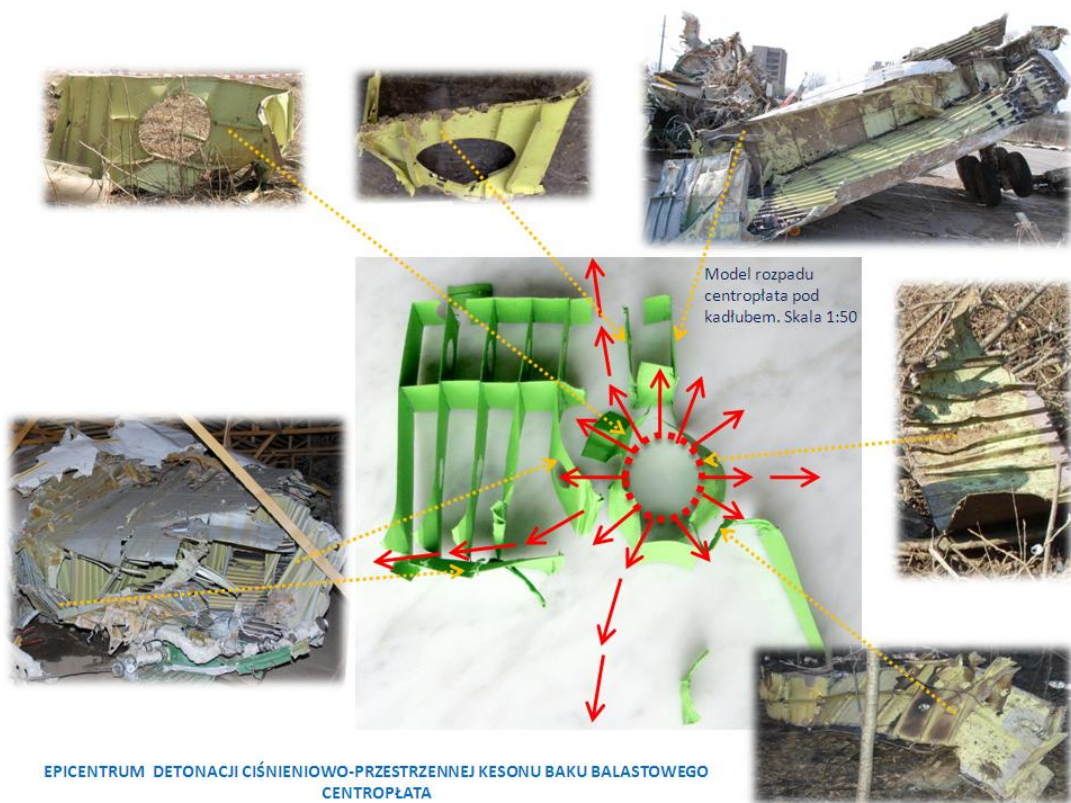
Fig. 38b. Epicenter of the wing box breakage. Study by the Committee.

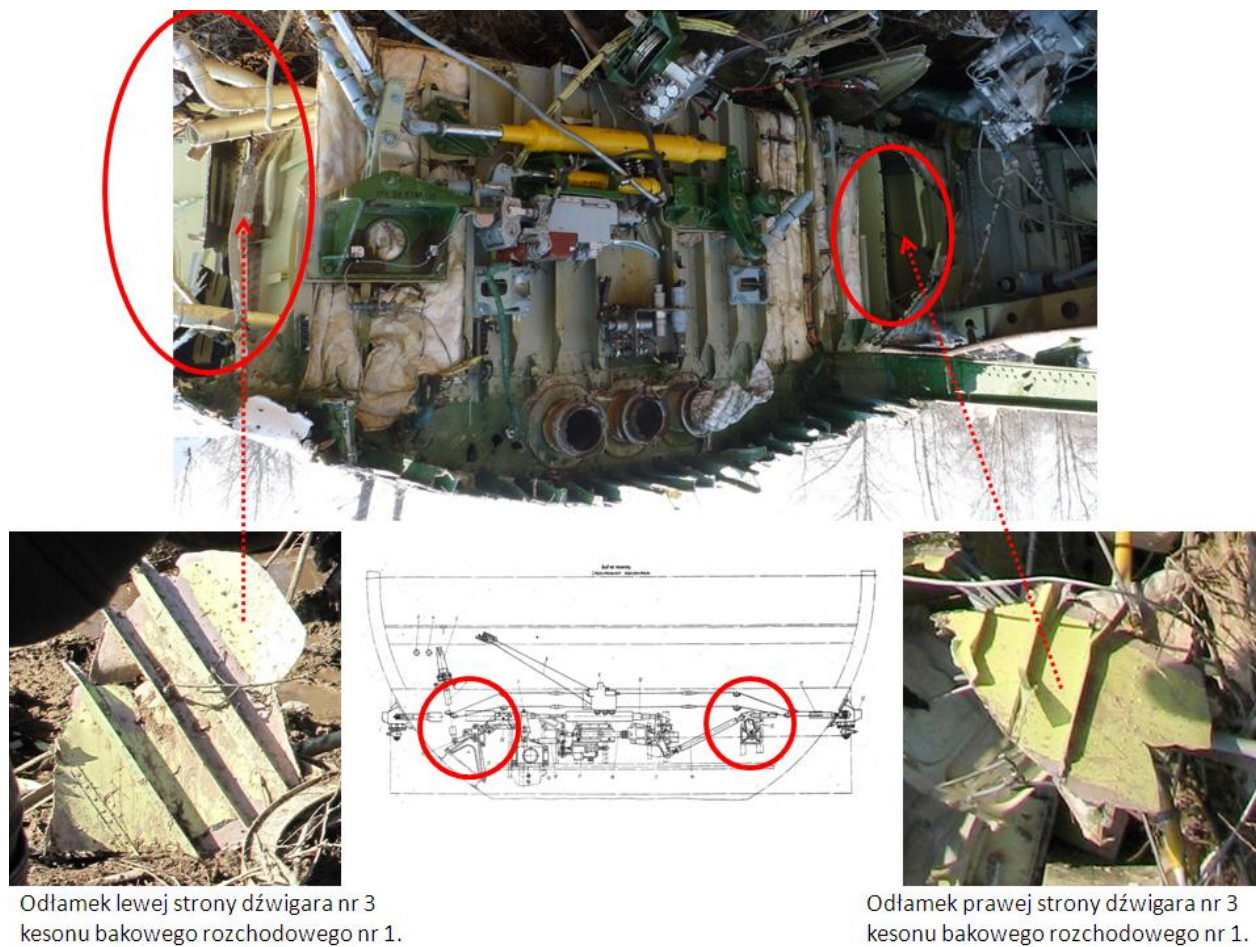
Fig. 40 Pieces of the left and right side of spar no.3 of fuel box no.1.

The torn off pieces of the rear spar No.3 of fuel box No.1 of the central part of the center wing.

The torn off pieces of the rear spar no.3 of the fuel box no.1 of the central part of the center wing confirms the theory that the destruction was a result of an explosion and not a hydraulic impact to its front wall during the fall of TU154M to the ground.

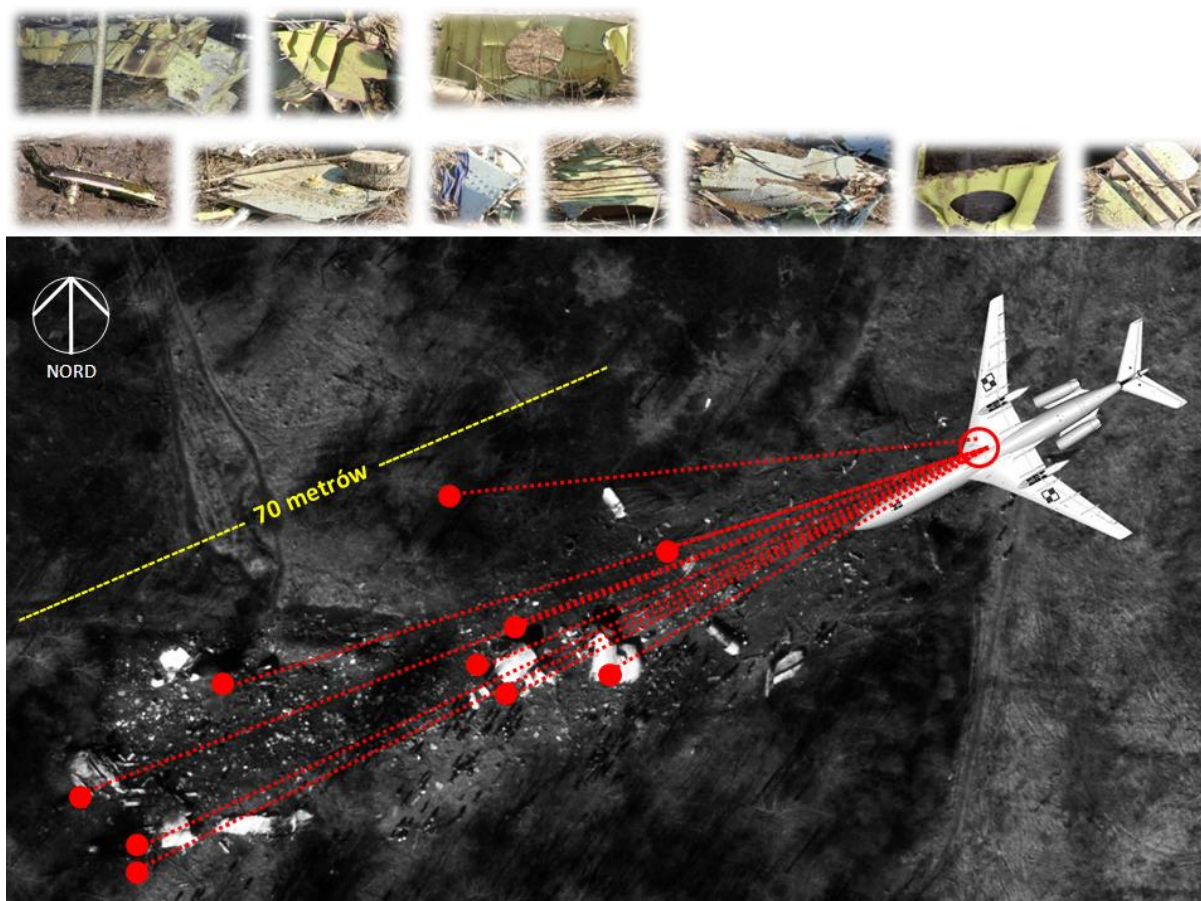
Fig. 41. General dispersion of the pieces of the centerwing on the crash site with the distance and place where the most important pieces fell.

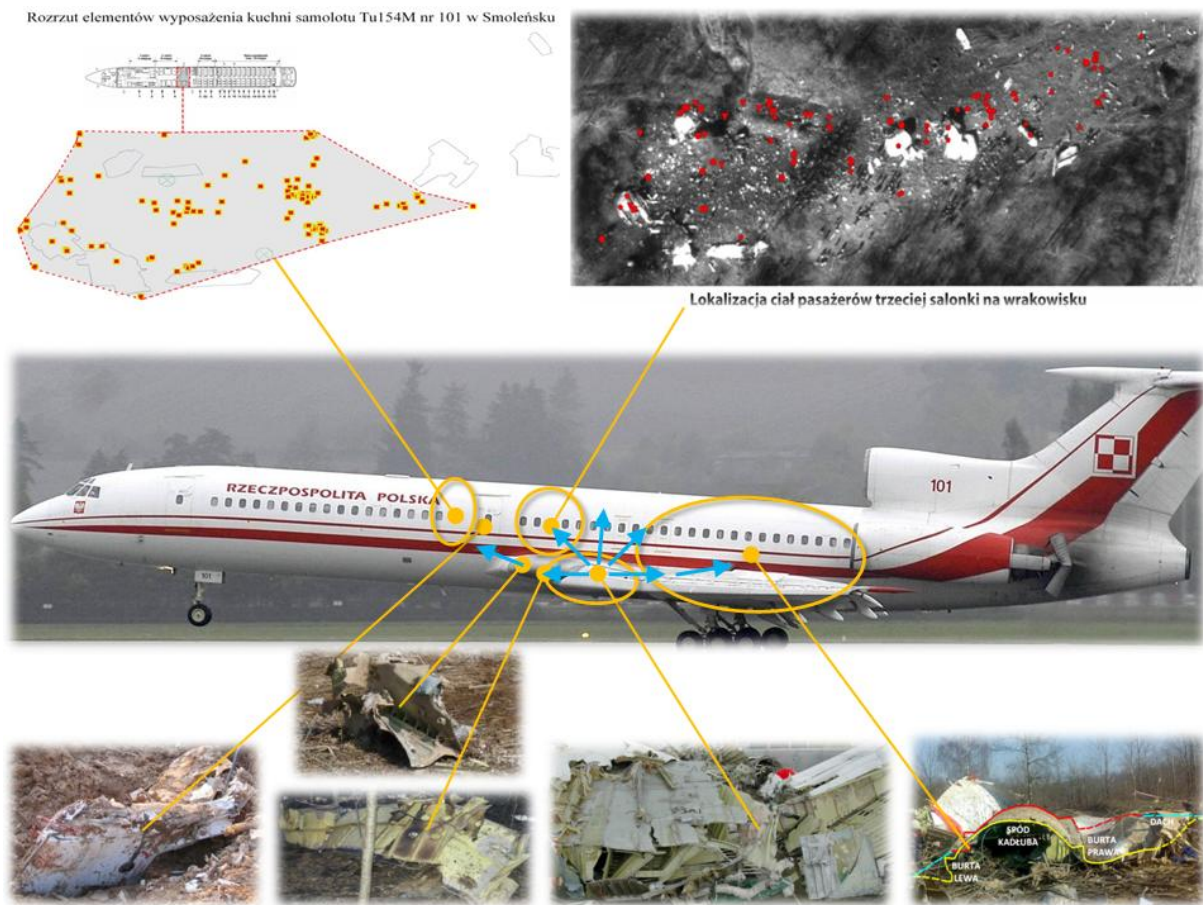
The explosion of the ballast box (Fig. 42) was the main reason for the destruction of TU154M a moment before it hit the ground. The destruction, which took place, destroyed the box, meaning the fragment of the left part of the center wing together with the front spar and destroyed soothed ribs. This spar flew and landed 70m to the west. The explosion destroyed the third salon, killing all the occupants and distributing those parts on the entire crash site. At the same time the detonation wave blew away the left passenger door (2L), which were rammed into the ground with huge force, one meter deep. The galley and thousands of its pieces were dispersed over 1/3 of the crash site area. The detonation wave, heading in the

direction of the tail, destroyed this part of the fuselage and curled the left and right side of the plane together with the roof outwards. The floor panel, which is torn off alongside the left side of the airplane provides evidence for the direction of the blast wave.

Fig. 42. The effects of the explosion of the ballast tank caisson. From the left of the top picture: galley area, left passenger door no 2. (823), third salon, fragments of the left part of the center wing, passenger compartment. The bottom left picture shows the left door rammed into the ground. The bottom right picture shows the rear fuselage after the crash with both sides opened outwards.

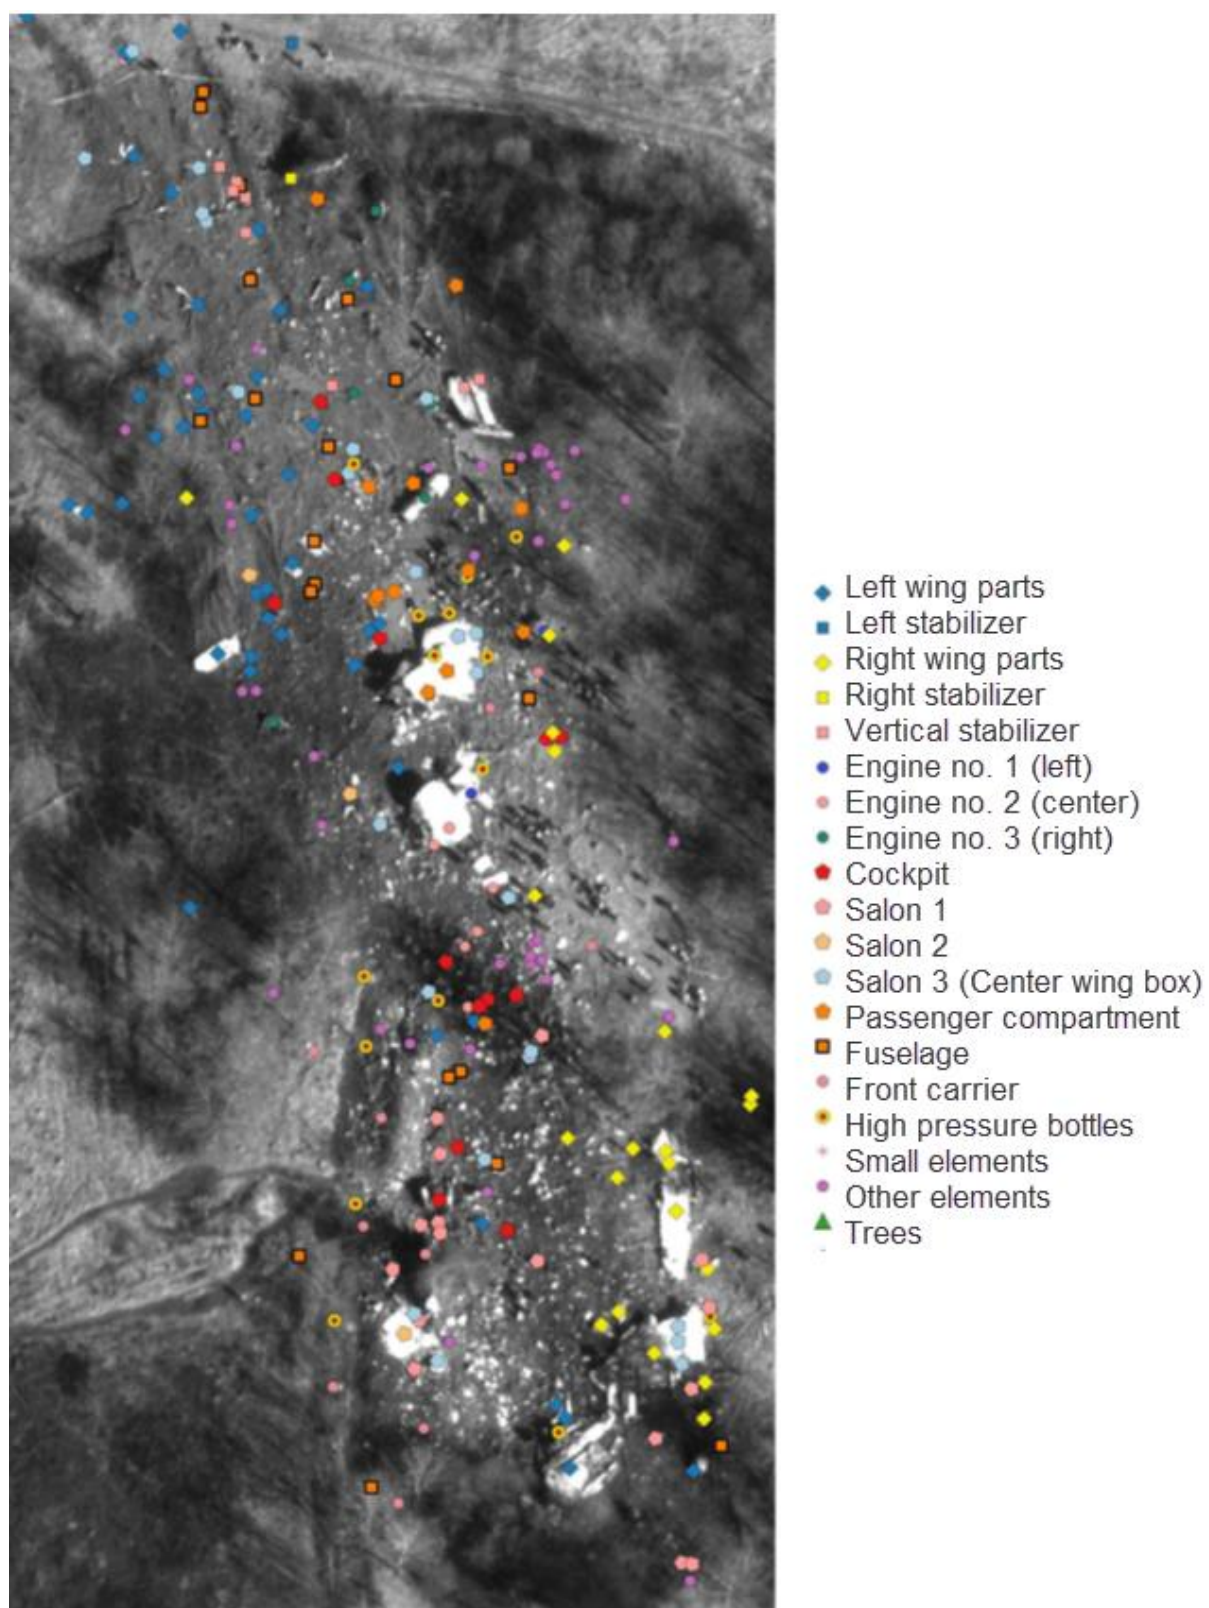
Fig. 43. Dispersion of part of the aircraft on the wreck. Study of the Committee. The direction of the flight is from the top left corner and down towards the bottom right corner.

The main crash site is 45mx160m, which means that the movement of the aircraft in this area, with its total destruction, happened in a distance corresponding to 3 lengths of the plane. The plane's impact on the ground happened in the reverse position to the aircraft, which is visible based on the dispersion of pieces of the left and right wing at the crash site. Indentations were observed in the ground at the place of the crash but without a deep crater. On the entire crash site there is no trace of a strong impact of the fuselage in the ground. All the seats were totally destroyed, meaning that the seating part, back lean, armrest, frame lay separately. Apart from the front part of the fuselage between the nose and the beginning of the center wing, pieces from the right side of the plane were found mainly on the left side of the crash site, and pieces from the left side of the plane were found mainly on the right side of the crash site.
