Report on experimental research concerning the destruction with the use of explosive materials of a construction imitating a part of the fuel box in the left wing of TU154M, 2018

Doc No: PW/WB/GAJ-080717-01 Experiment: cutting the wing model with the use of a linear explosive charge, 2017

The disintegration of the plane from TAWS38 to Kutuzov Street

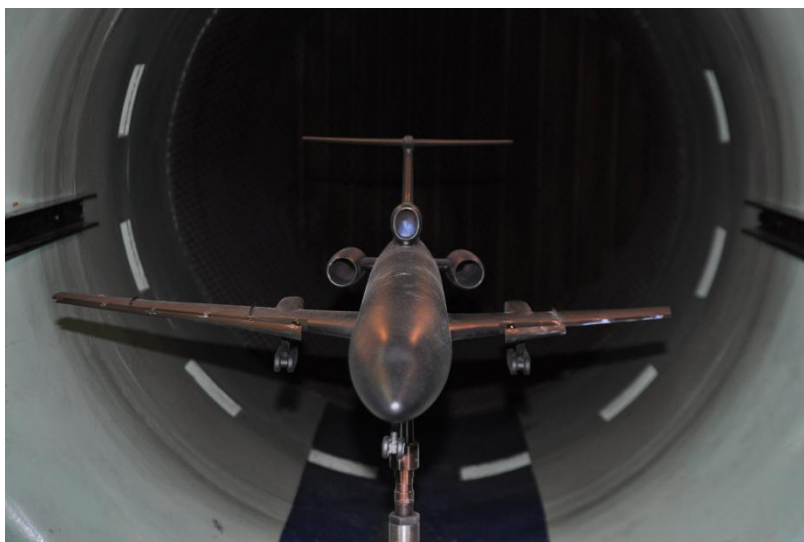
Experiments in the aerodynamic tunnel, conducted in IL, showed that the loss of lift force between 4.8% and 8.7%, due to the loss of the left wingtip, does not have to end in a left roll. This work shows that the pilots, even with an angle of attack up to 11.5degrees, can fully balance the rolling moment by introducing a 7degree sideslip (they have to change the configuration of the plane so that the left wing is moved forward). Further balancing is possible with the move of the right aileron. A side slip is an element of basic aviation training and instinctive for every experience pilot, which is used during side-wind. When losing 1/3 of the left wing, the decreased wind resistance on this side will result in a right-turn of the plane to the sideslip with the left wing to the front. (Fig. 25).

Fig. 25. Airplane model in the wind tunnel of the Institute of Aviation. Here in version with a cut left wing and without slats and the outer flap.

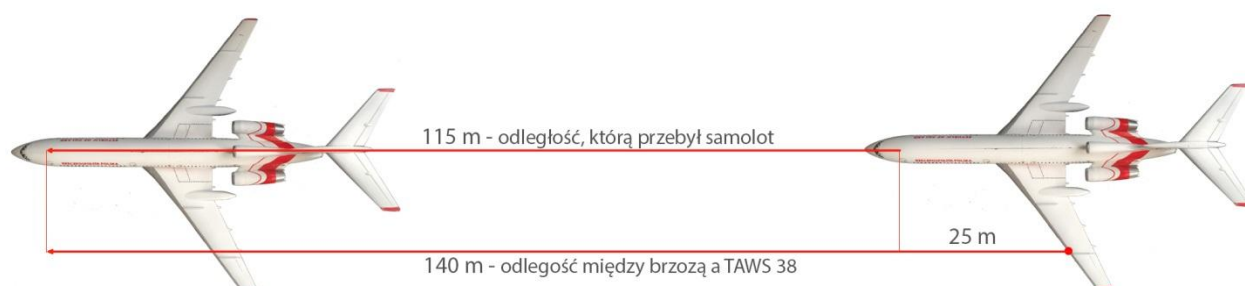
The distance between the so called bb tree and TAWS38 is approx. 140m. The distance that the plane traveled between the places of supposed contact of the wing with the bb tree, as assumed in the Miller and MAK reports, and TAWS 38 was 115m.

Fig. 26. The difference in distance from the tree, that is claimed to have made wing contact with TAWS38 (140m) and the distance that the plane travelled (115m). The distances are different as the GPS antennas are located 25m in front of the hypothetical zone of contact.

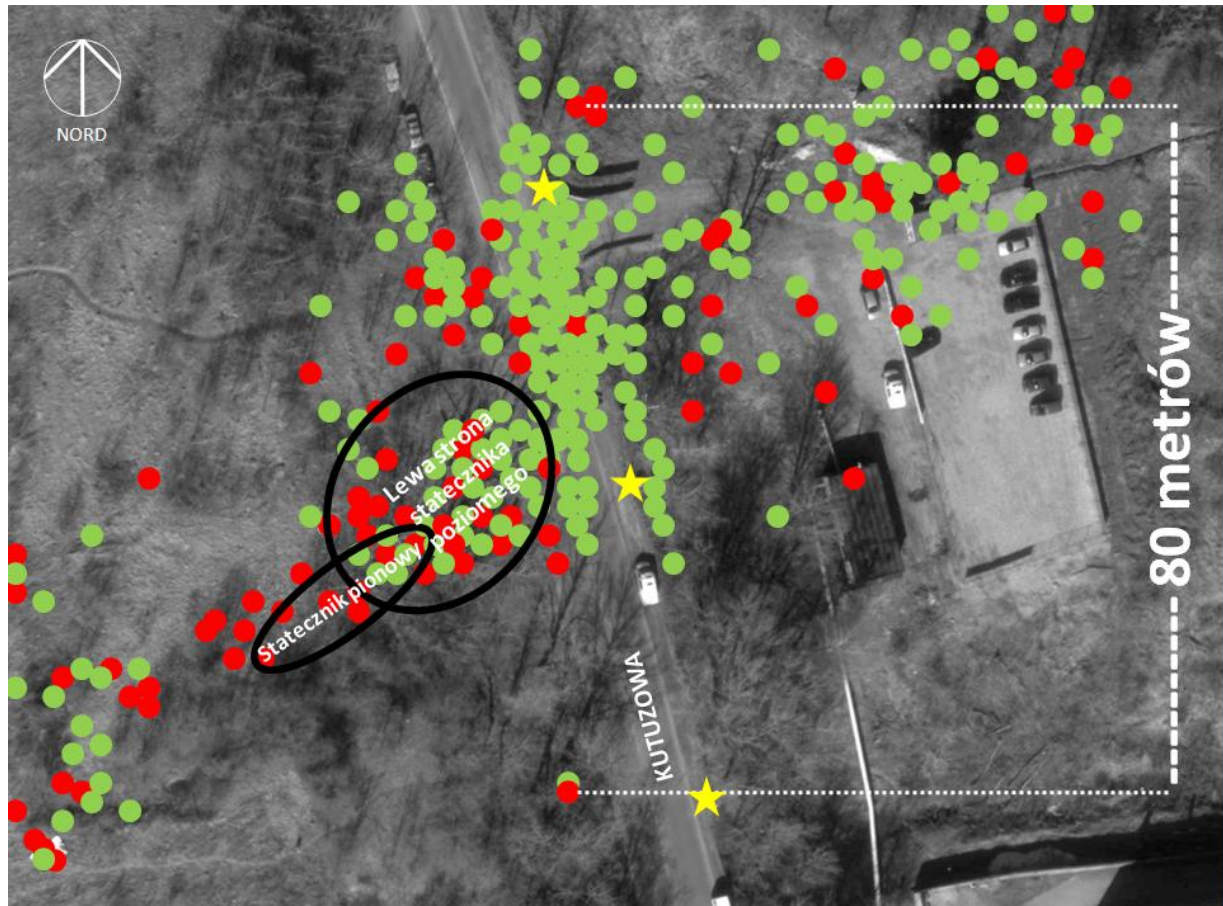
One line of elements from the left horizontal and vertical stabilizer (stemming from the area, where it was connected to the horizontal stabilizer) behind the Kutuzov street shows that the roll of the plane was large and the dispersion of parts falling off the plane and destroyed branches points to a sudden destruction of the plane in the air (Fig. 27).

Fig. 27. Placing the left side of the horizontal stabilizer and the vertical stabilizer behind Kutuzov highway. Flight direction is from right to left. Red dots show debris from the Tu-154M and green dots show debris from the associated tree damage.

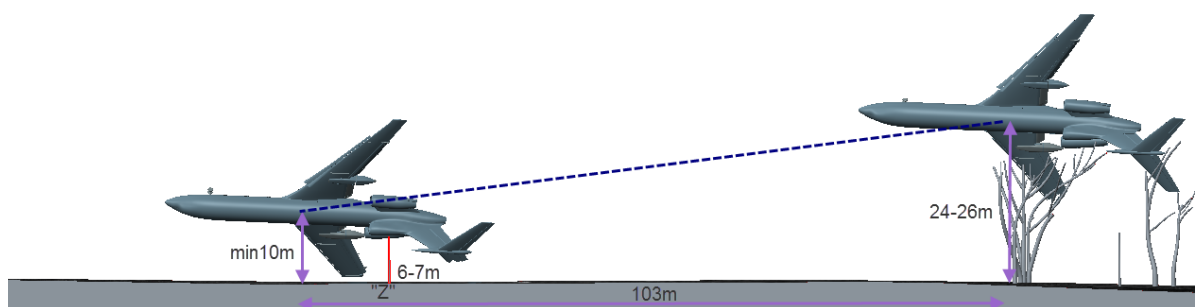
A 6-7 meter high tree marked with the letter “Z” on fig 29 to fig. 31b and directly above the trajectory of flight was not damaged by the plane which means that the altitude to the balance point in that moment, when the tail passed the “Z” tree, was at least 10m.

Fig. 29. A view to the north at the moment the plane flew from Kutuzov street (right) to the crash site (left). The 6-7m tall tree is here marked with the letter "Z".

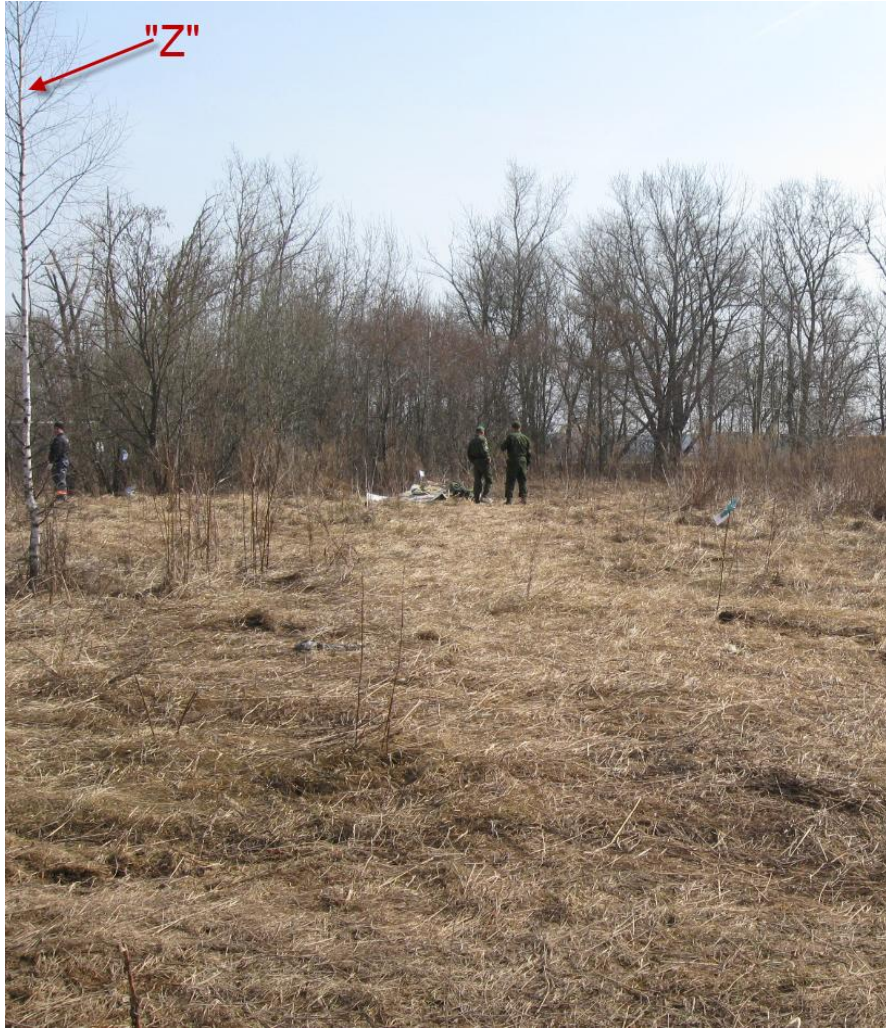
Fig. 30. The tree marked "Z" growing in the direct vicinity of the flight path, when the plane was flying from Kutuzov Street (in the background) to the place of crash. On the right side, starting at the blue marker on a stick there is a visible ground trace when the ground was hit with the left stabilizer.

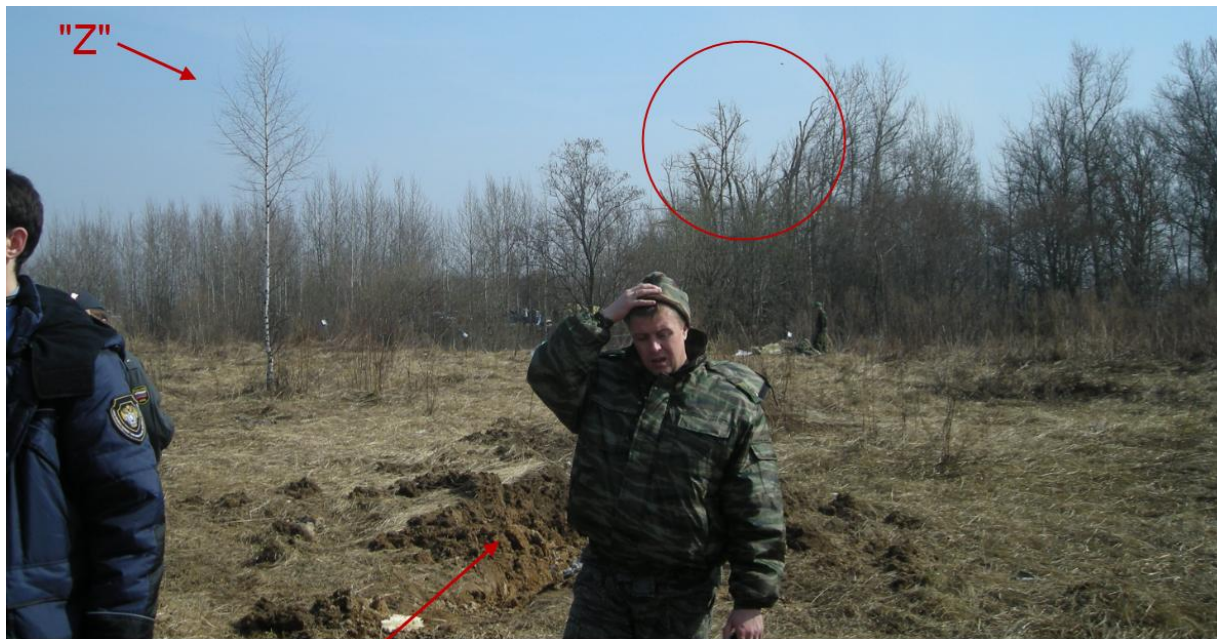
Southern Ground Trace

Fig. 31a. The tree marked "Z" growing in the direct vicinity of the flight path, when the plane was flying from Kutuzov Street (red circle) to the place of the crash. The ground trace from the tail is visible and marked here as "Southern Ground Trace".

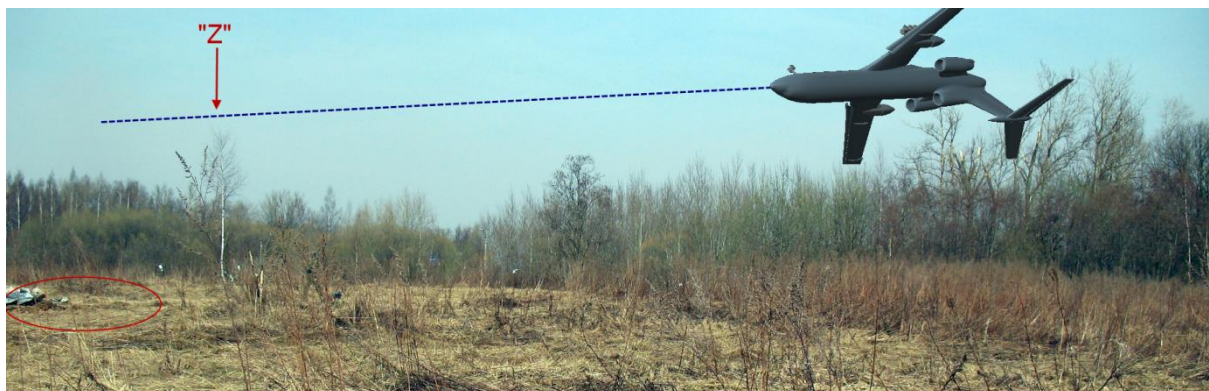
Fig. 31a. The tree marked "Z" growing in the direct vicinity of the flight path, when the plane was flying from Kutuzov Street (right side) to the place of the crash (left side). The ground trace from the tail is visible and marked here with a red ellipse. The white part inside the ellipse shows the new position of the left horizontal stabilizer after Russians had moved it 35m closer to the crash site.

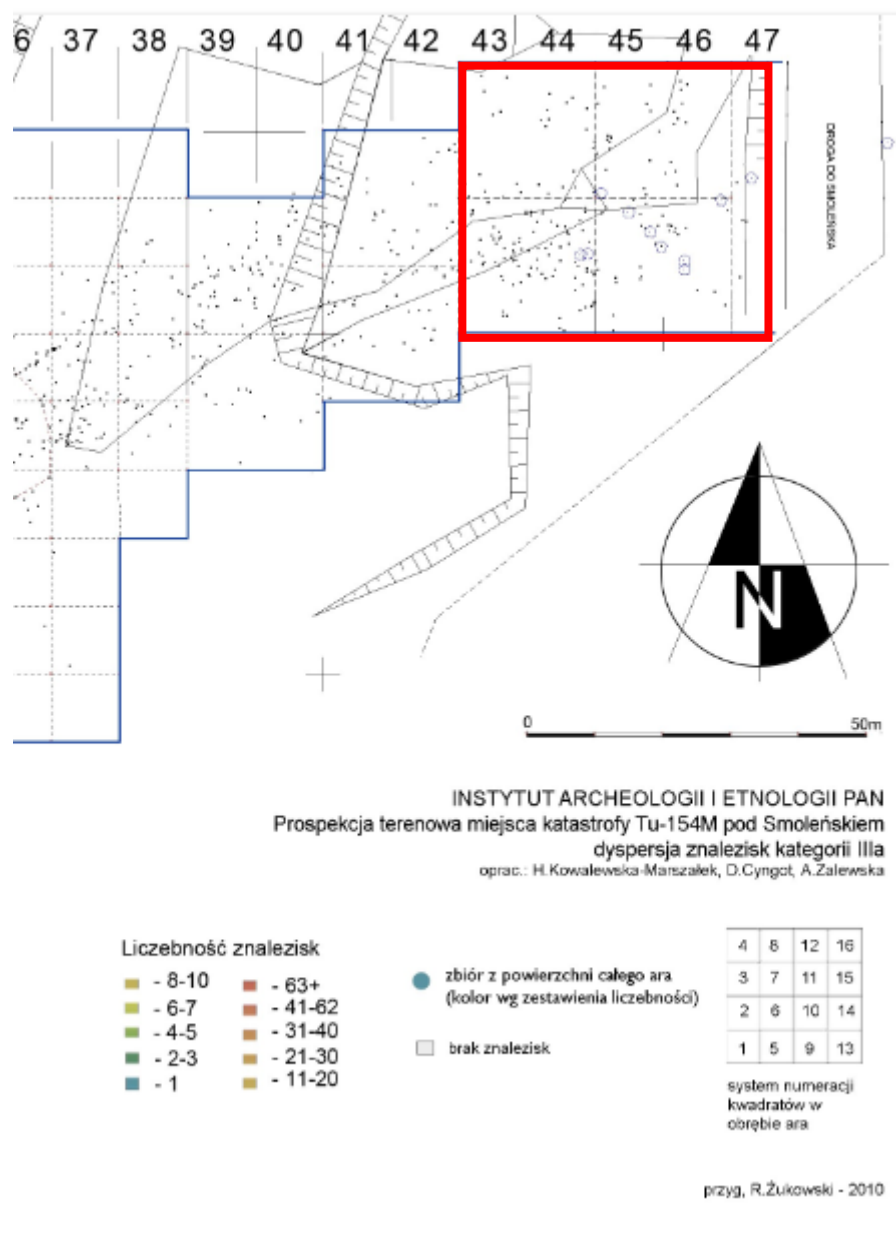
During a terrain analysis, done by Polish archeologists in Smolensk in October 2010 in sector 13 behind Kutuzov Street and before the main crash site, numerous pieces of the plane were found (fig 32). Those pieces, varying in size, from a couple to tens of square centimeters, had traces of thermal and mechanical effects (fig 33).

Fig. 32. Map from the archeologists report showing where pieces were found behind Kutuzov street (marked "Droga do Smolensk" at the right).

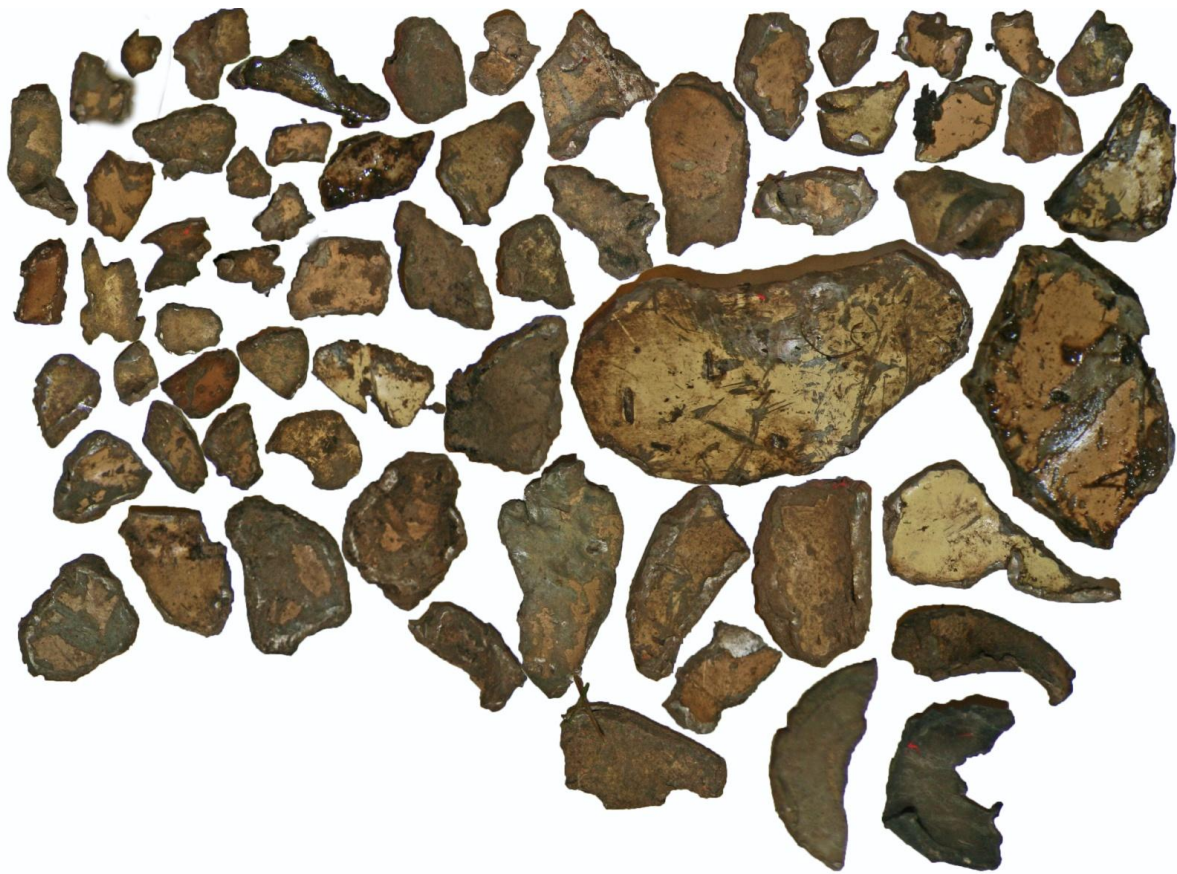
Fig. 33. Pieces collected of the Tu-154M, taken from the ground 100m before the main crash site showing thermal traces.

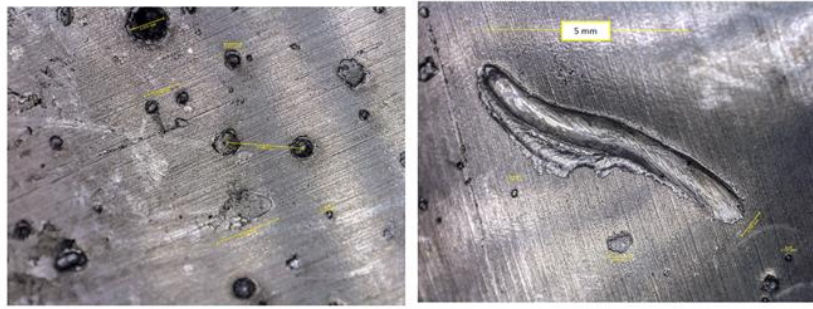
Part of the pieces had characteristic traces (micro craters) on its surface. This corresponded in shape and size with the traces left by pieces which were created after the pyrotechnical experiment performed by the Committee. (Fig. 34).

This feature is characteristic for an explosive destruction.

Fig. 34. Comparison of micro craters on the surface of the pieces found by archeologists and pieces created after pyrotechnical experiments.
