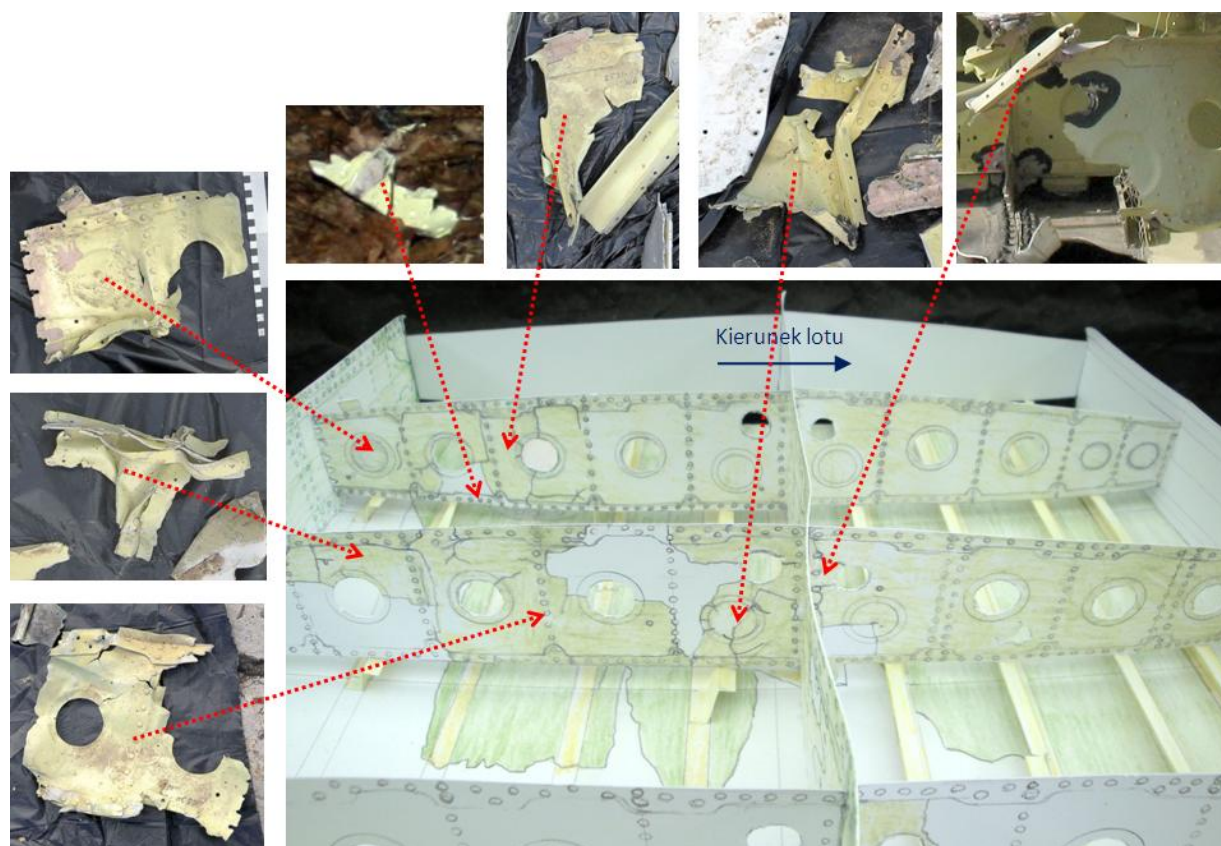
Some pieces of the left wing rib, which according to the MAK and Miller reports were supposed to have had contact with the bb tree, were torn off the construction (Fig. 11)

**Fig. 11.** Condition of the ribs of the left wing according to the reconstruction made by the Committee.

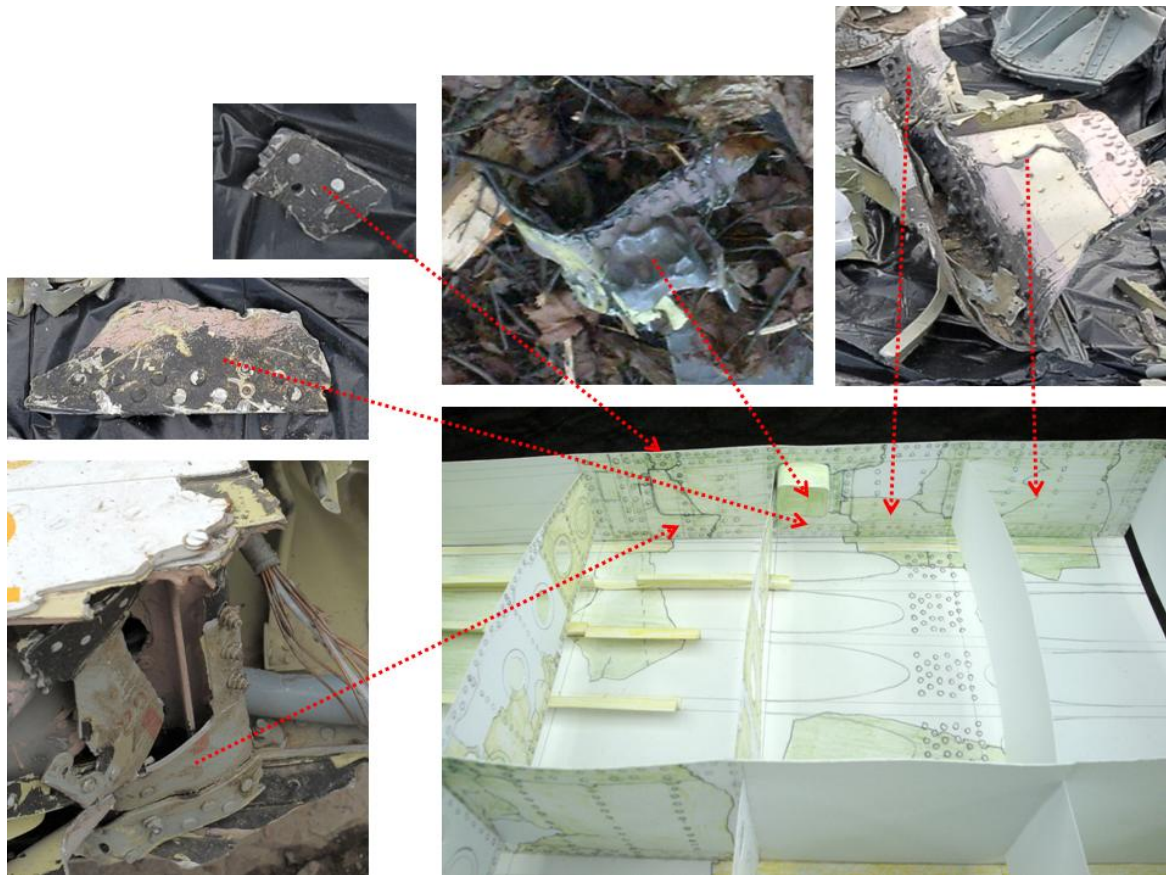
Some pieces of the wing spars from the detachable part of the left wing, which according to the MAK and Miller reports were supposed to have had contact with the bb tree, were torn off or bent outwards (Fig. 12,13 and 14)

**Fig. 12.** Condition of spar no.1 of the left wing according to the reconstruction made by the Committee based on pictures and movies.

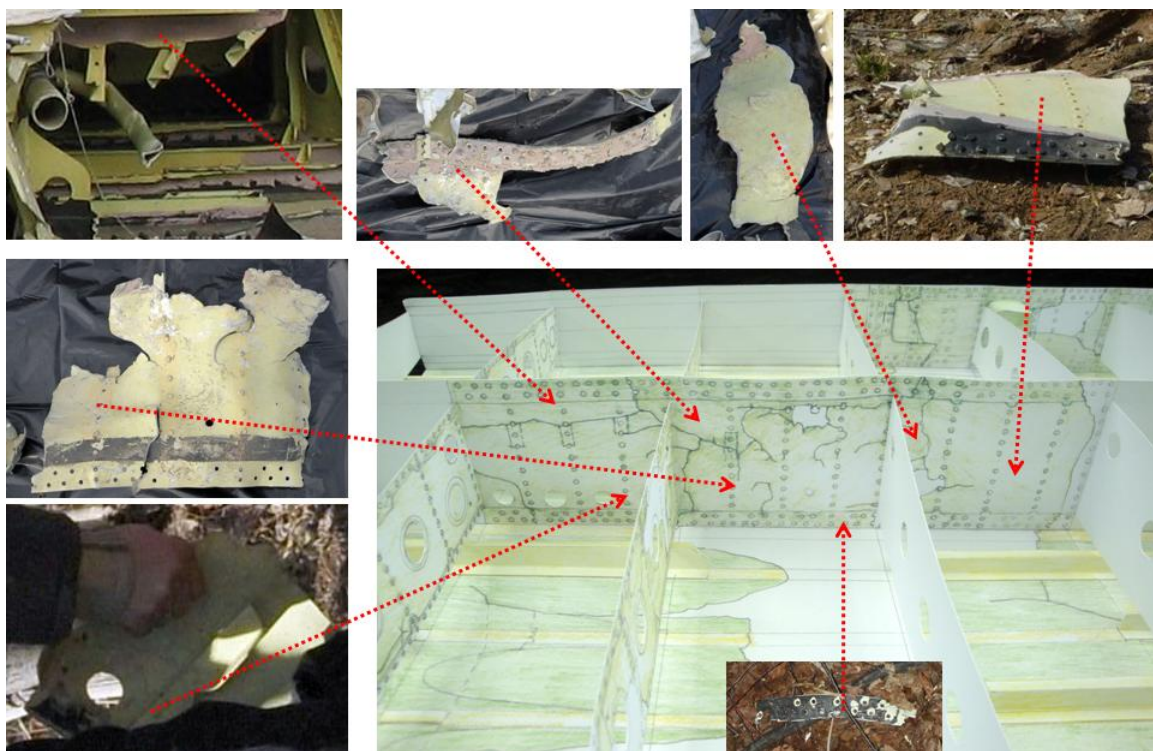
**Fig. 13.** Condition of spar no.2 of the left wing according to the model reconstruction made by the Committee, based on pictures and movies.

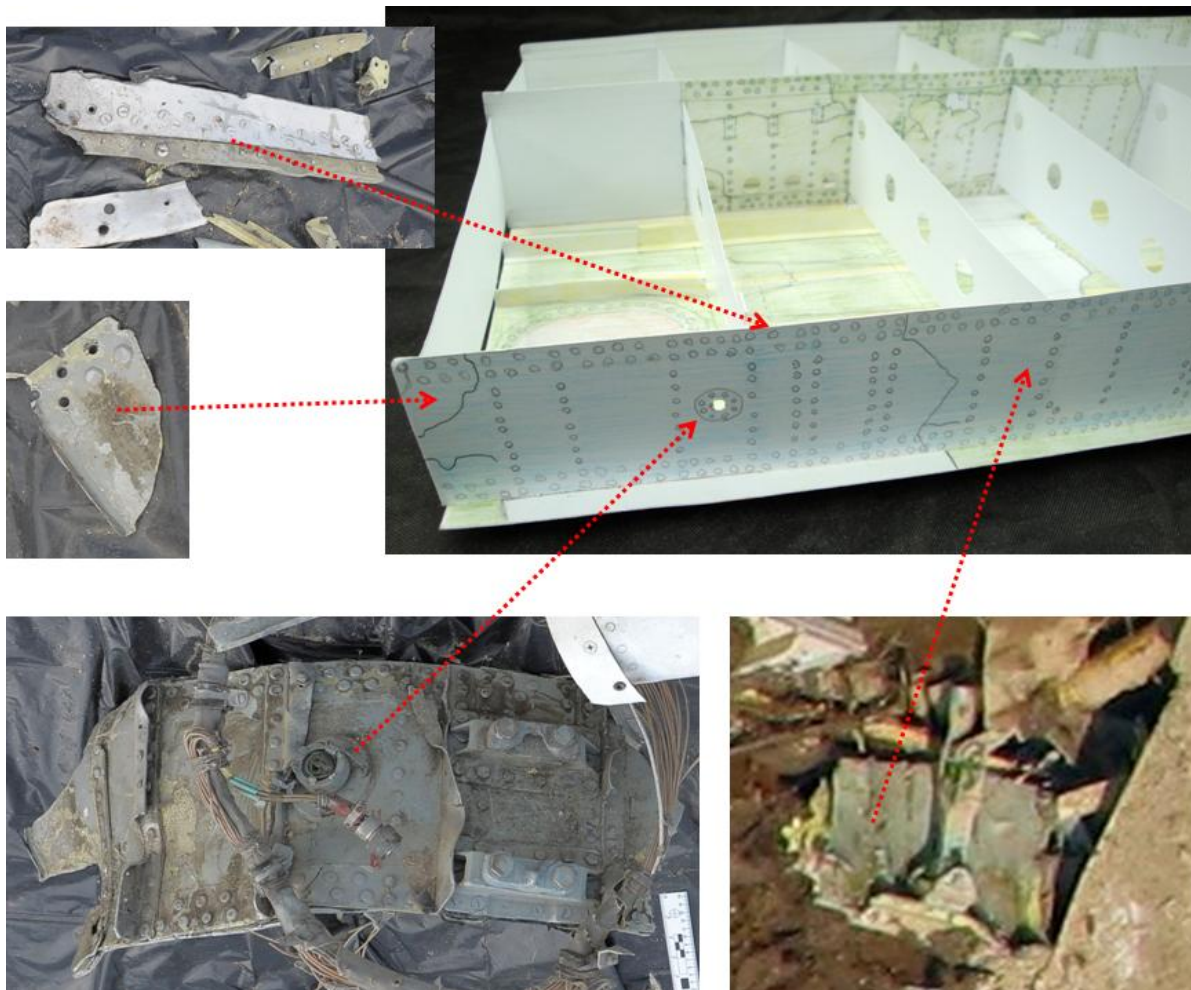
**Fig. 14.** Condition of the third spar of the left wing according to the model reconstruction made by the Committee.

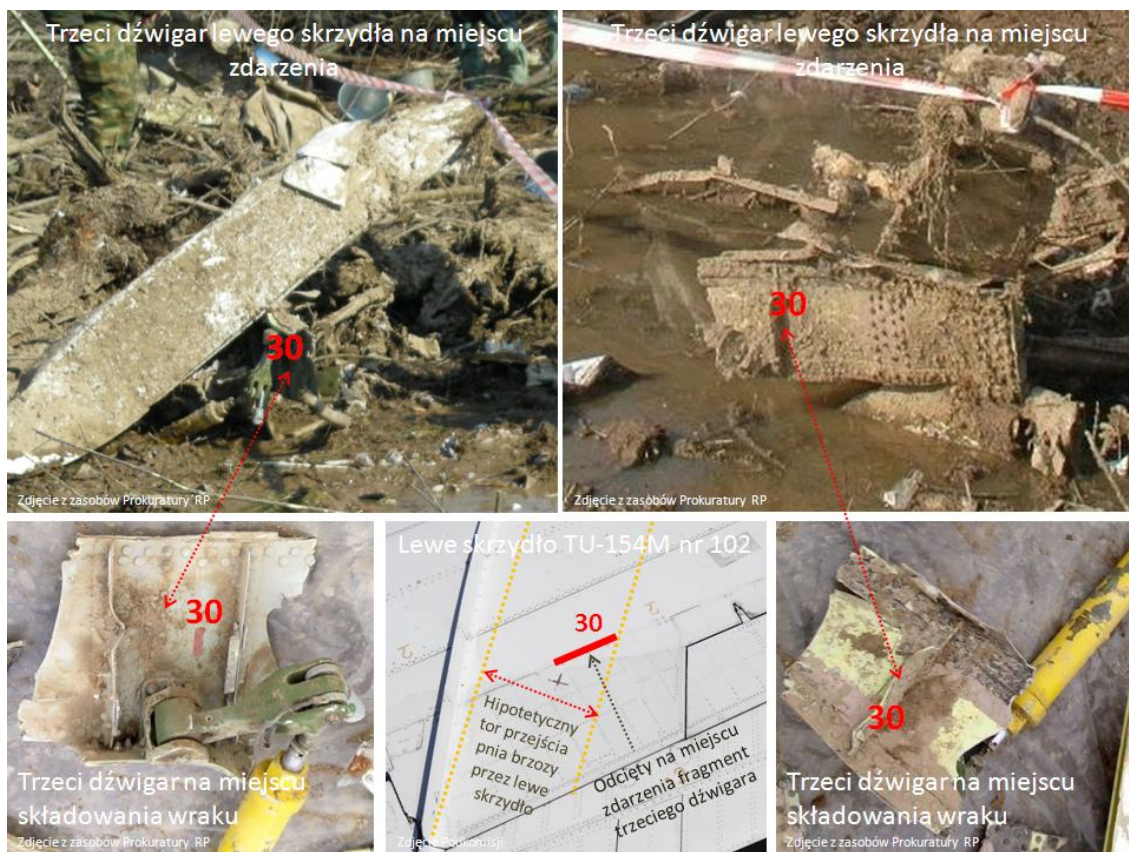
A fragment of spar no.3 of the left wing, which according to the MAK and Miller reports was supposed to be cut by the so called bb tree, was found on the main crash site 450m behind the birch tree and then cut. Its separated pieces were found in various places of the debris storage place (Fig. 15)

**Fig. 15.** View of the same part of spar no.3 from the detachable part of the left wing on the main crash site and place of storage of the debris.

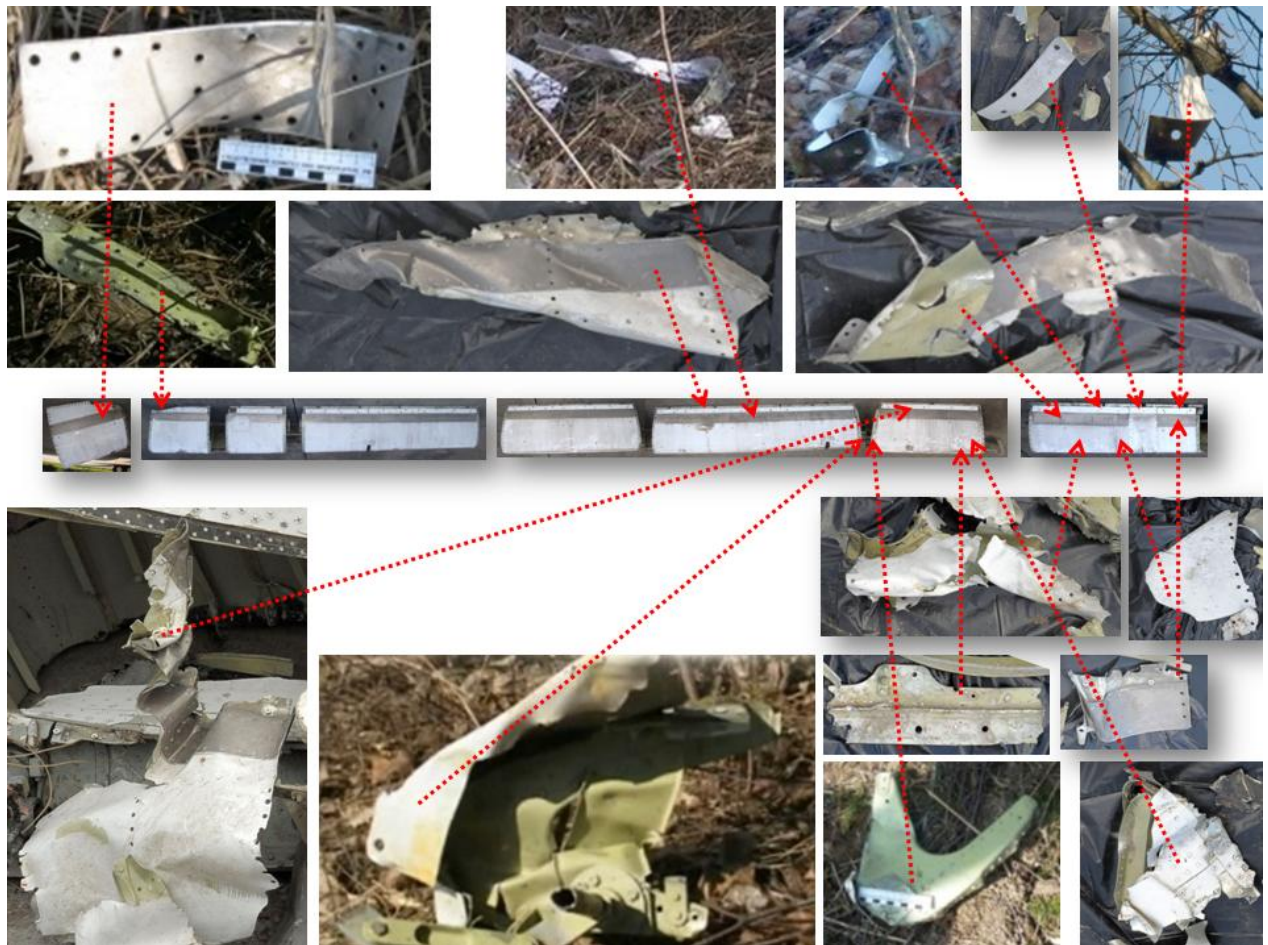
Some elements of the nose of the left wing, which according to the MAK and Miller reports were supposed to have had contact with the so called bb tree, were torn off or bent outwards (Fig. 16)

**Fig. 16.** Condition of the nose of the left wing according to the model reconstruction made by the Committee

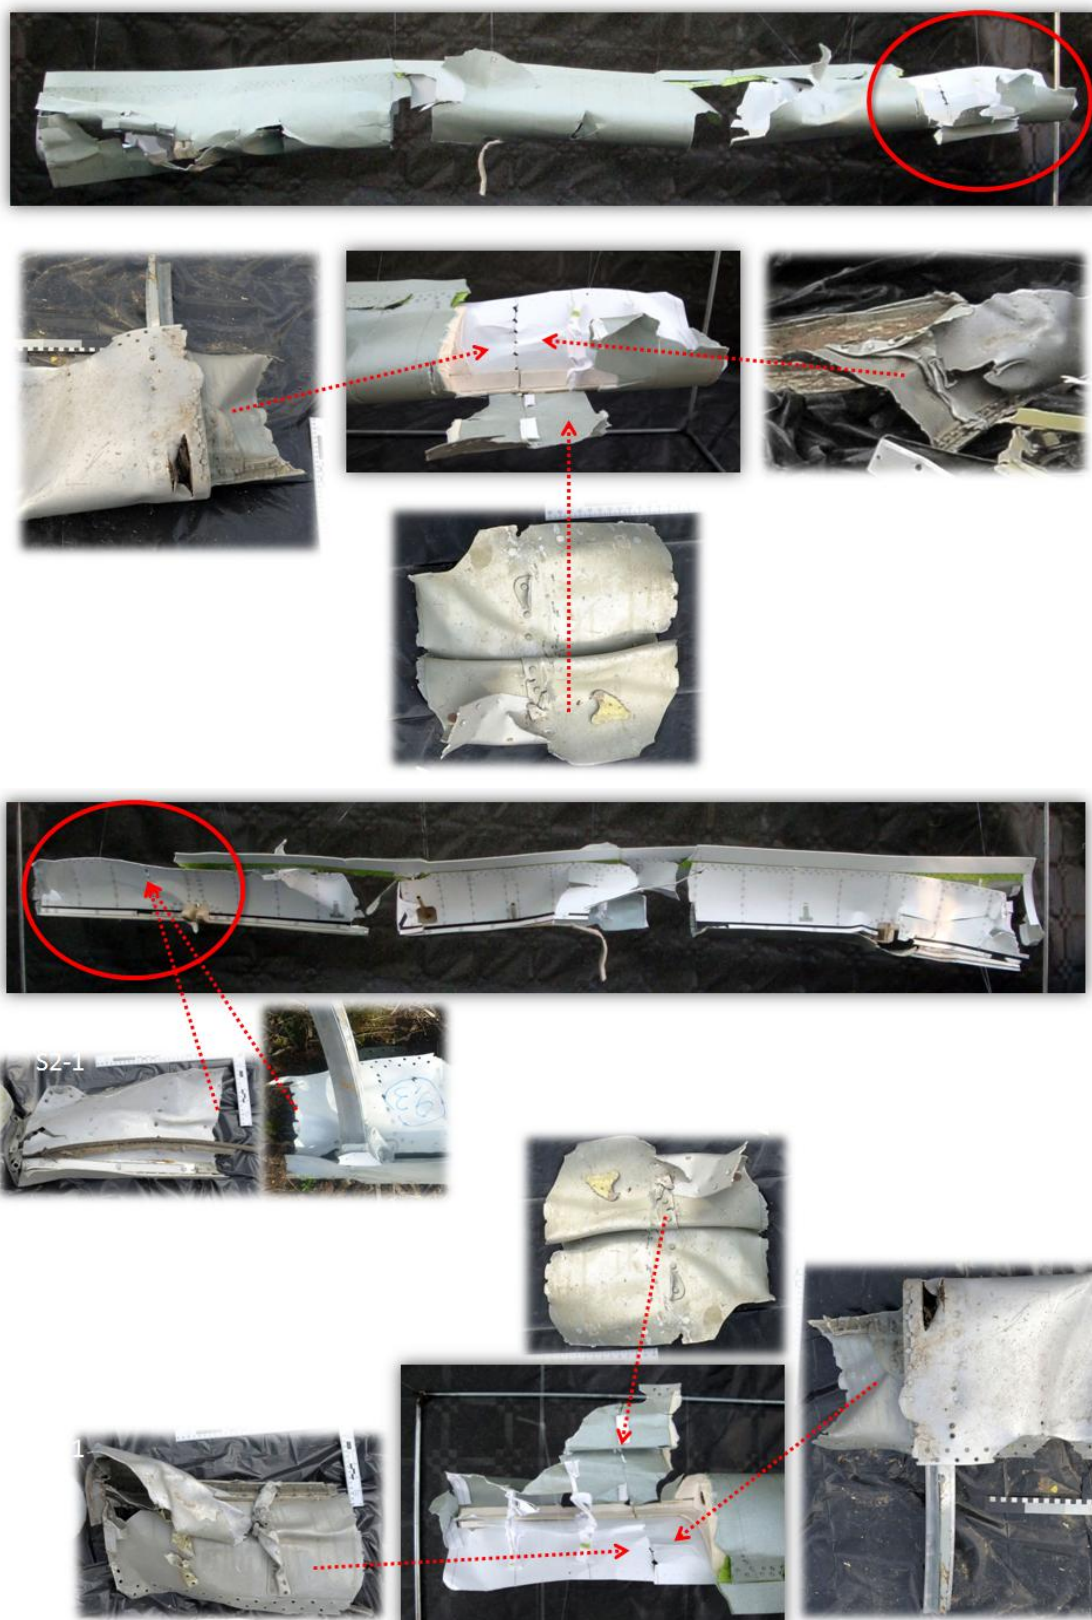
Some pieces of the second section of the left wing slats, which according to the MAK and Miller reports were supposed to have had contact with the so called bb tree, were torn off or bent outwards; upper side upwards and bottom side downwards, and from the side of the angle of attack to the front (Fig. 17).

**Fig. 17.** Condition of the second section of the left wing slat according to the model reconstruction made by the Committee

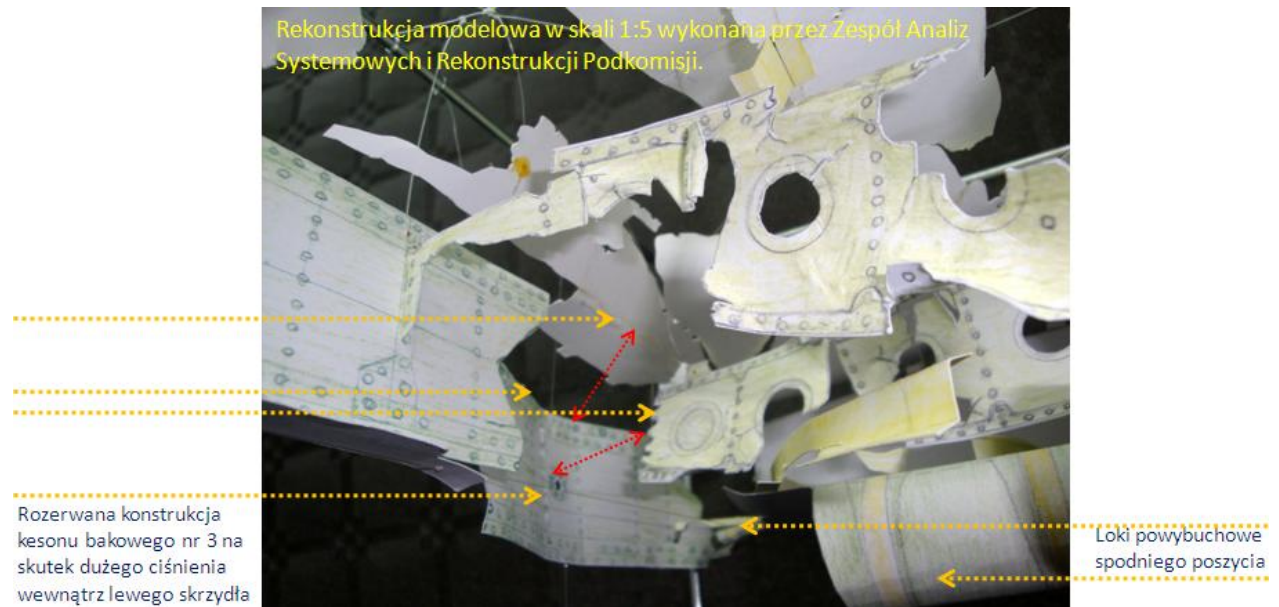
shows clear signs of deformation as a result of high internal pressure with the epicenter being between ribs 27-32 (Fig. 18.)

**Fig. 18.** Reconstruction of the console of the subtracted part of the left wing with elements of the internal structure, bearing traces of deformation through the impact of high internal pressure, whose epicenter is between the ribs No. 27-32.

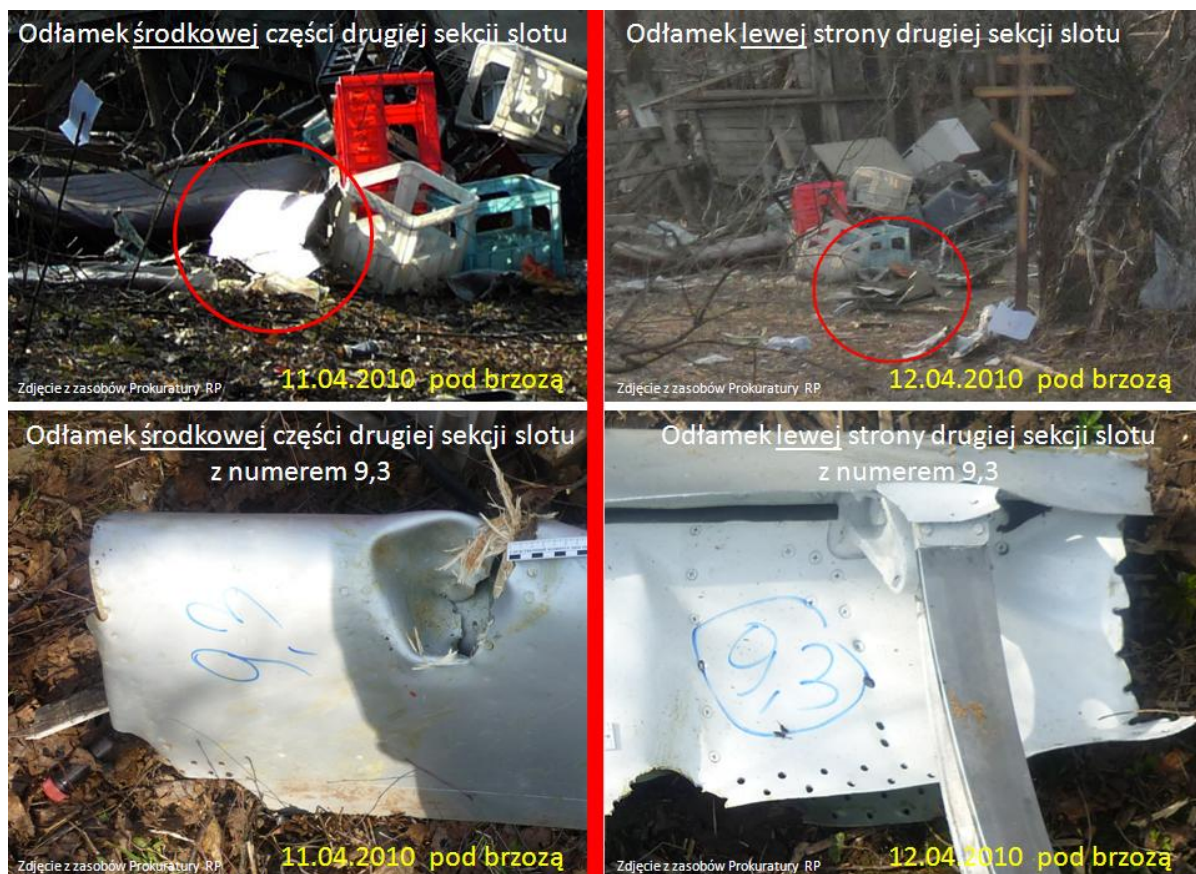
**Example:** One of the pieces of the 2nd section of the slot, which fell in to the ditch next to the road leading from the garages to the Gubienko street approx.20m behind the birch tree, was moved on the 11.04.2010 under the bb tree. On April 12 it was swapped with another piece stemming from the line of separation (which fell in to the ditch next to the street leading from the garages to Gubienko Street, approx. 50m behind the birch). Picture 19

**Fig. 19.** Fragments of 2 sections of the slot moved from the original location on the ground under the tree claimed to have made contact with the wing.

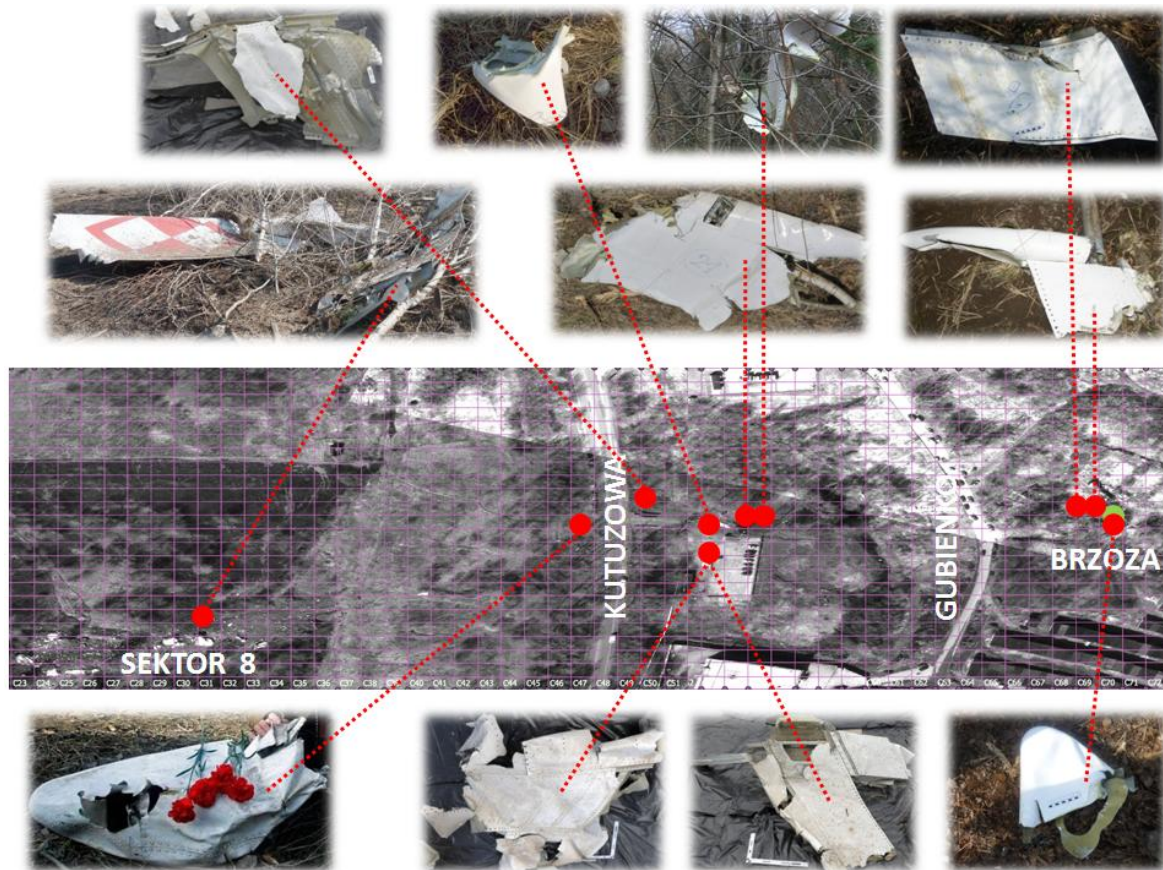
The majority of elements from the flaps of the detachable wing part were scattered from the bb tree in the direction of the main crash site in an area 15m-225m according to the flight direction of TU-154M. (Fig. 20).

**Fig. 20.** The locations on the ground of various parts from the left wing.

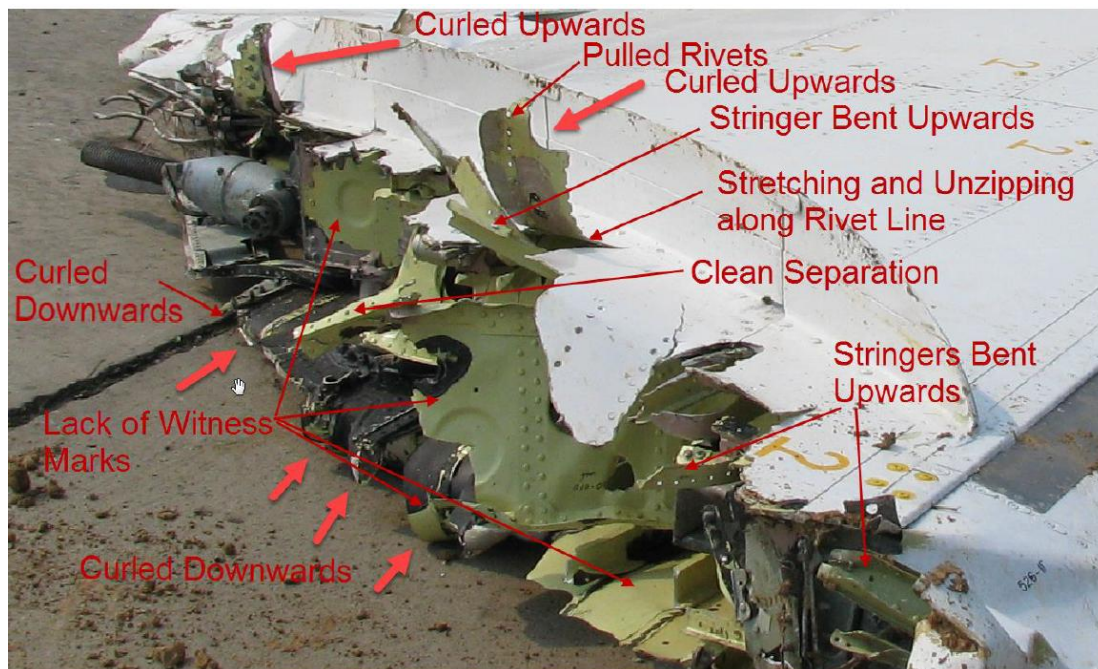
The separation place of the tip of the left wing is not parallel to the axis of the fuselage, but it creates a line deviating from this axis by 7.5-10 degrees.

The separation place of the left wing tip shows classical post-explosive signatures typical for the use of explosive materials, like irregularly curled edges with more than one turn. The broken area of the left wing tip shows a large number of the characteristic signs compatible with high internal pressure such as zipping of rivet lines, pulling of rivets and clean separation of skin from the remaining parts. (Fig. 21 and Fig.22).

**Fig. 21.** The area of separation of the left wingtip of TU-154M, PLF101 showing the classic and significant signs of explosion and an additional number of characteristic signs of an explosion.

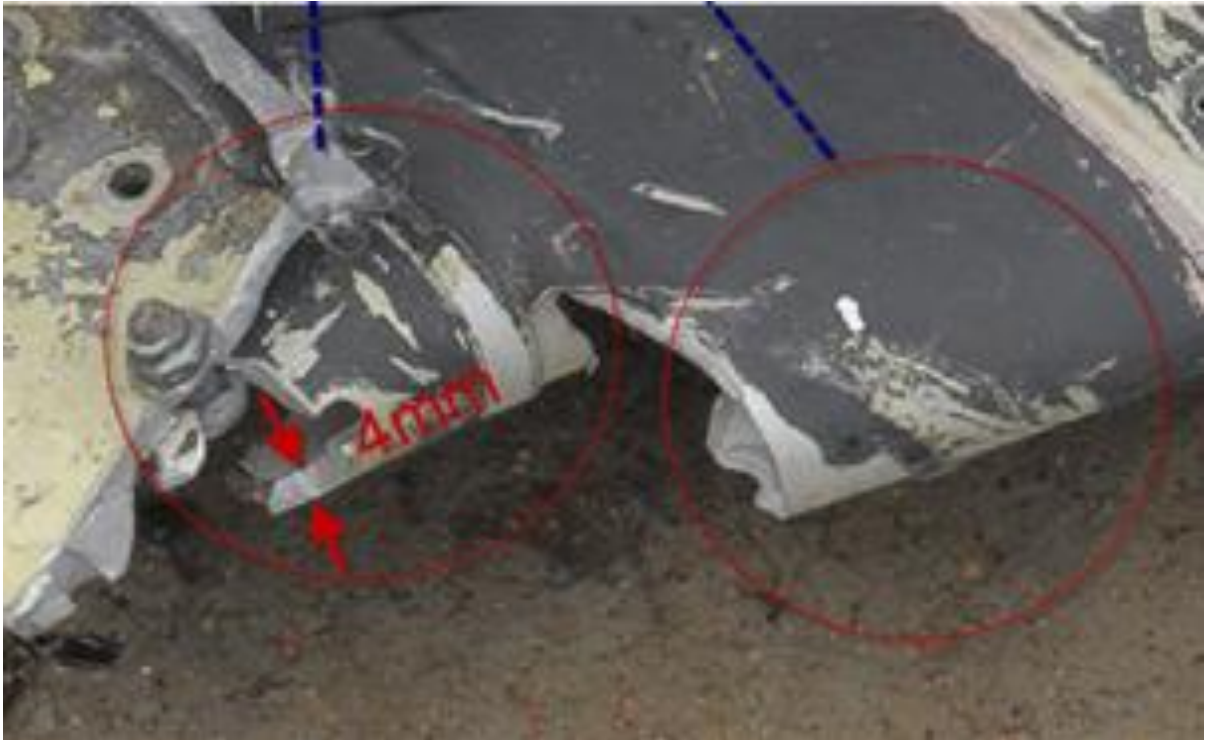
**Fig. 22.** A close-up of the photograph from Fig. 21 with visible post-shock curls with axis of curl in the direction of flight.

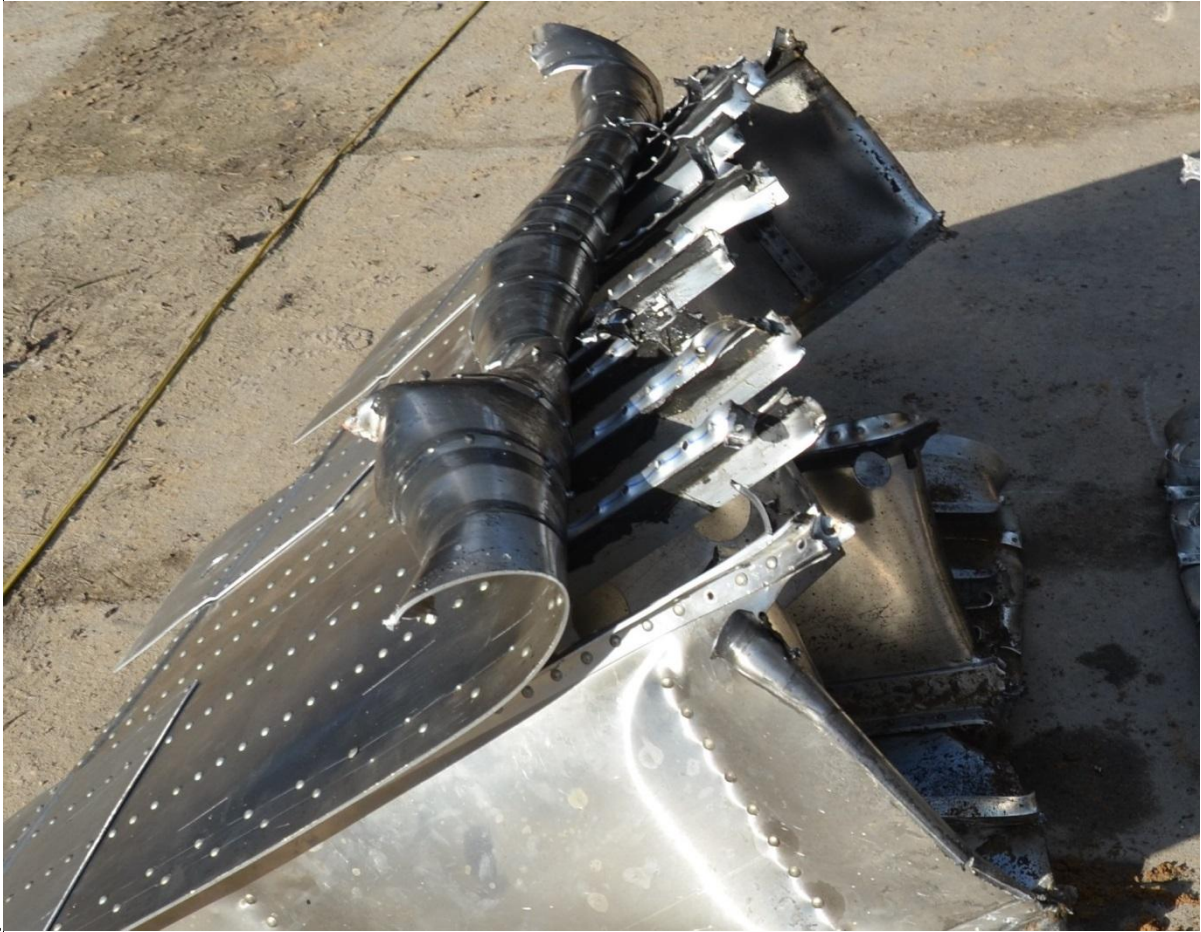
The experiments carried out by the KBWLLP Committee in March 2018 on the wing fragment model in the scale 1: 4 and 1: 1 show that the wing with fuel and fuel vapors can be destroyed by explosive charges with similar features of destruction of the structure without a major fuel explosion with many observed features similar to the wing tip in Smolensk. (Fig. 23 and Fig. 24)

**Fig. 23.** Scale 1:1 Separation by explosive material of the wing box containing fuel. The experiment demonstrated the wing could be cut without a secondary major fuel explosion.

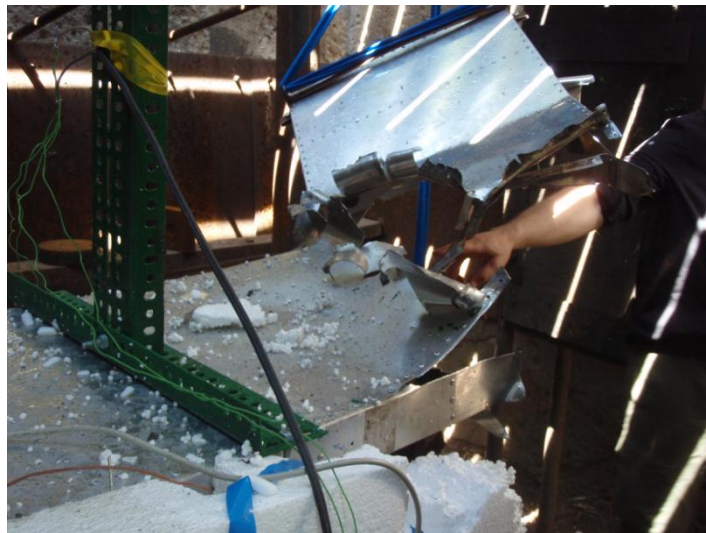
**Fig.24.** Experiment of cutting the wing model on a 1:4 scale with fuel, with the use of 6g/m PETN Cord. Note the direction of curls away from the area of high internal pressure. The experiment demonstrated the wing could be cut without a secondary major fuel explosion.
