**COMMITTEE FOR THE RE-INVESTIGATION
OF THE SMOLENSK AIR CRASH**

TECHNICAL REPORT

**Facts regarding the crash of the TU-154M No. 101,
(Fight PLF101), that took place in Smolensk, Russia on the 10th of April 2010**

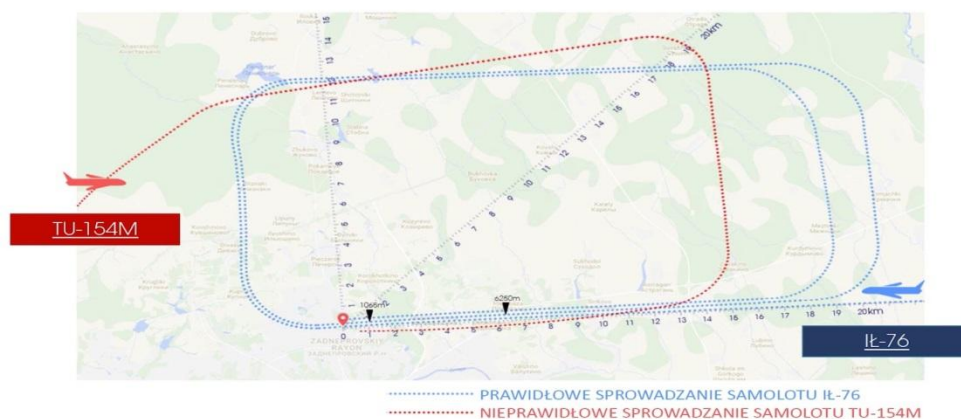
Fig. 1. Comparison of guidance of IL-76 and TU-154M on April 10th, 2010.

A two-time landing approach of IL-76 ended with the plane flying approximately 170 meters to the left of the runway axis.

The guidance of the TU-154M was performed with a systematic misleading of the Polish pilots by Russian general V. Benediktov, who supervised the guidance of the crew of TU-154M from the "Logika" (Eng. "Logic") headquarters in Moscow. The crew of the TU-154M performed all approach procedures correctly.

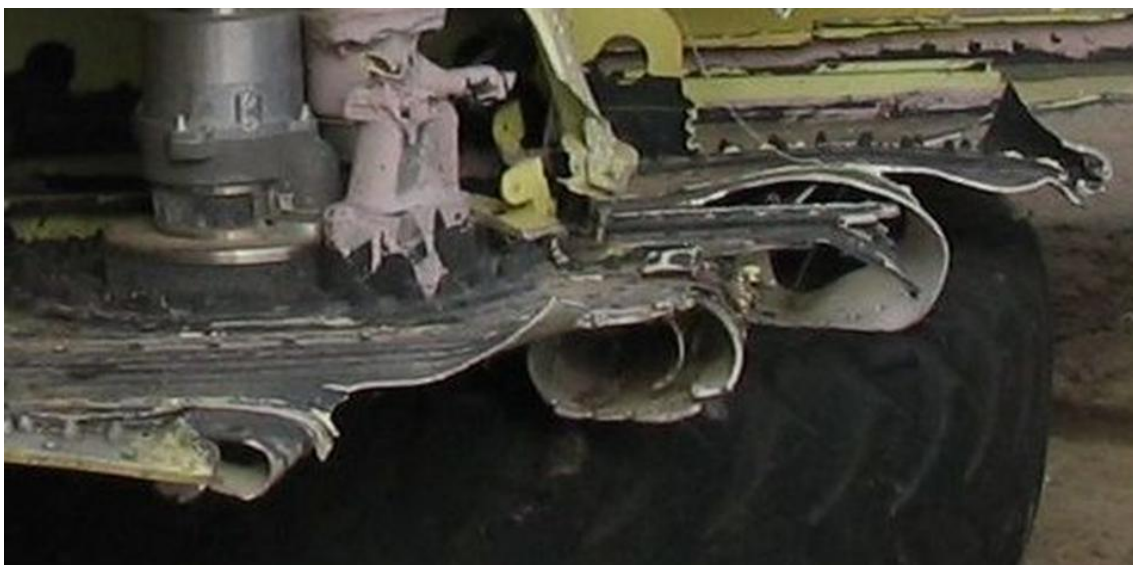
The wing tip shows a number of curls up to 450° seen as significant signs of explosion. In addition a long number of characteristic signs of explosion can be seen (Fig.2).

Fig. 2. Side view of the broken section of the left wing tip of TU-154M no.101 showing significant explosive signatures (curled edges of up to 450°).

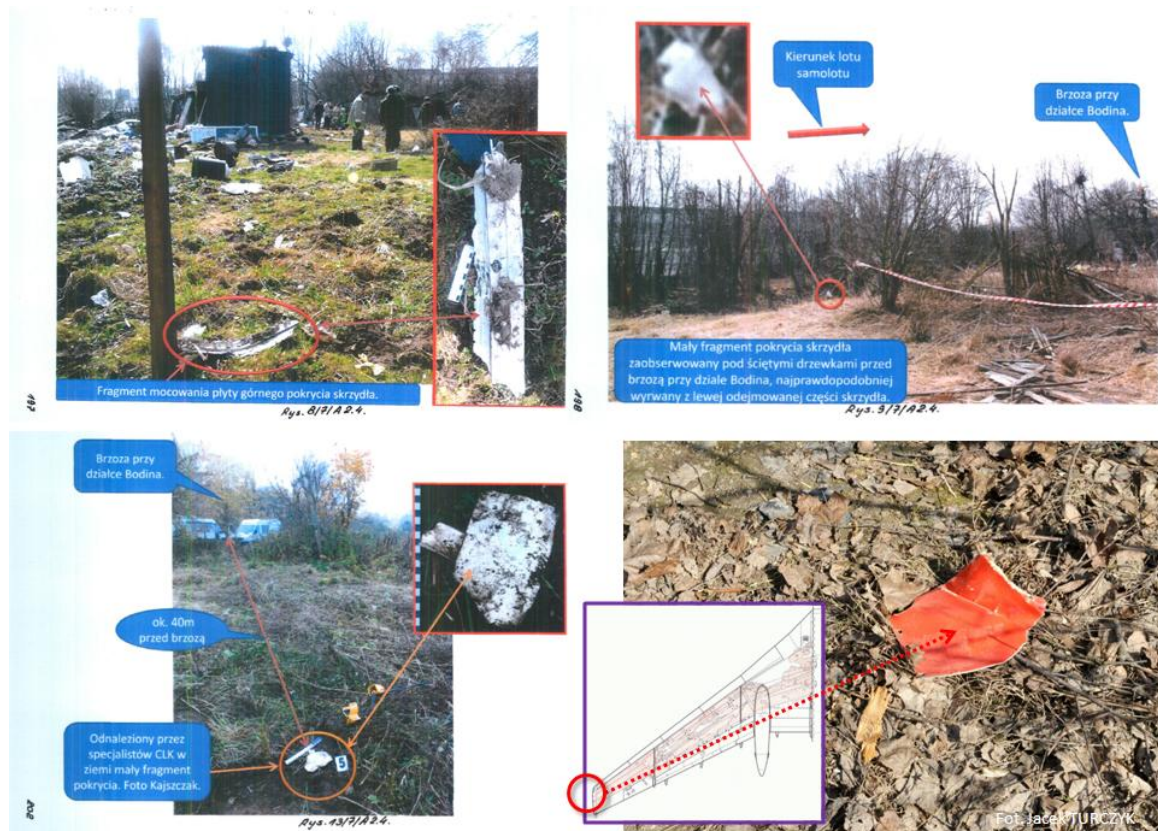
Many pieces of the left wing, in the vicinity of the Bodin birch (bb), were found in front of the tree in an area of 41 meters north and 17 meters south in the direction perpendicular to the flight direction, and 43 meters to the east of the tree (Fig. nr.3)

Fig. 3. Debris of the detachable part of the left wing identified by the Committee and experts of the Prosecutor's Office of the Republic of Poland.

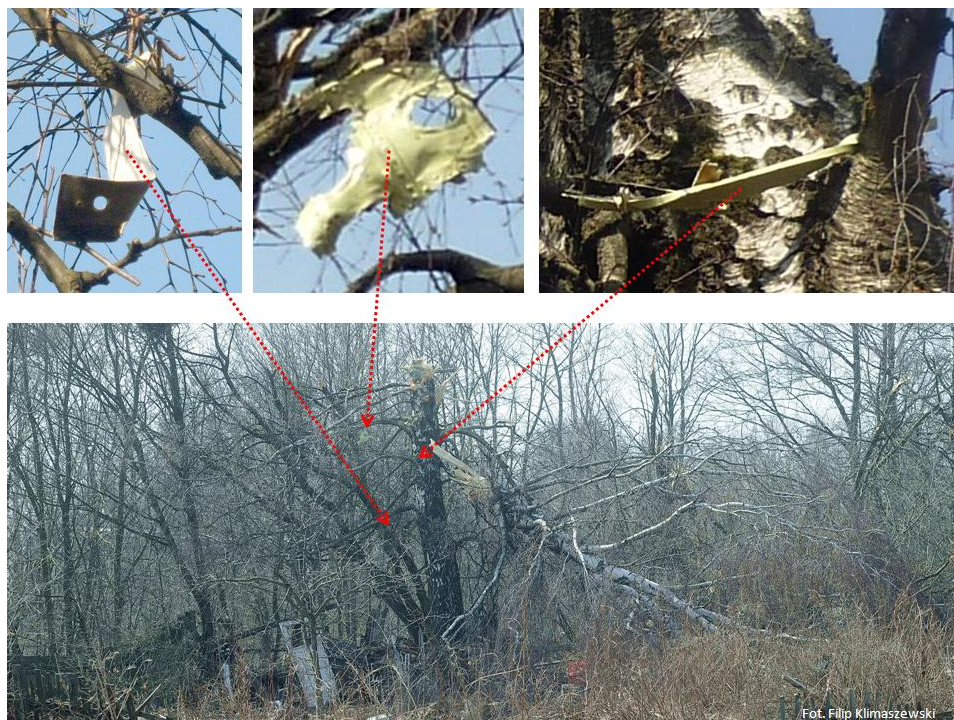
Three pieces of the detachable part of the left wing were hanging on the branches of the so called Bodin birch (Fig.4).

Fig. 4. Identified pieces of the detachable left wing part hanging on April 10, 2010 on the branches of (Bodin) birch tree claimed to have cut the wing (noted "bb").

Experiments conducted by the Committee in 2016 on an element in 1:1 scale with a similar shape and weight to one of the hanging elements showed that the distance needed to lose velocity, and to land on the branch is at least 100m and a height not less than 26m.

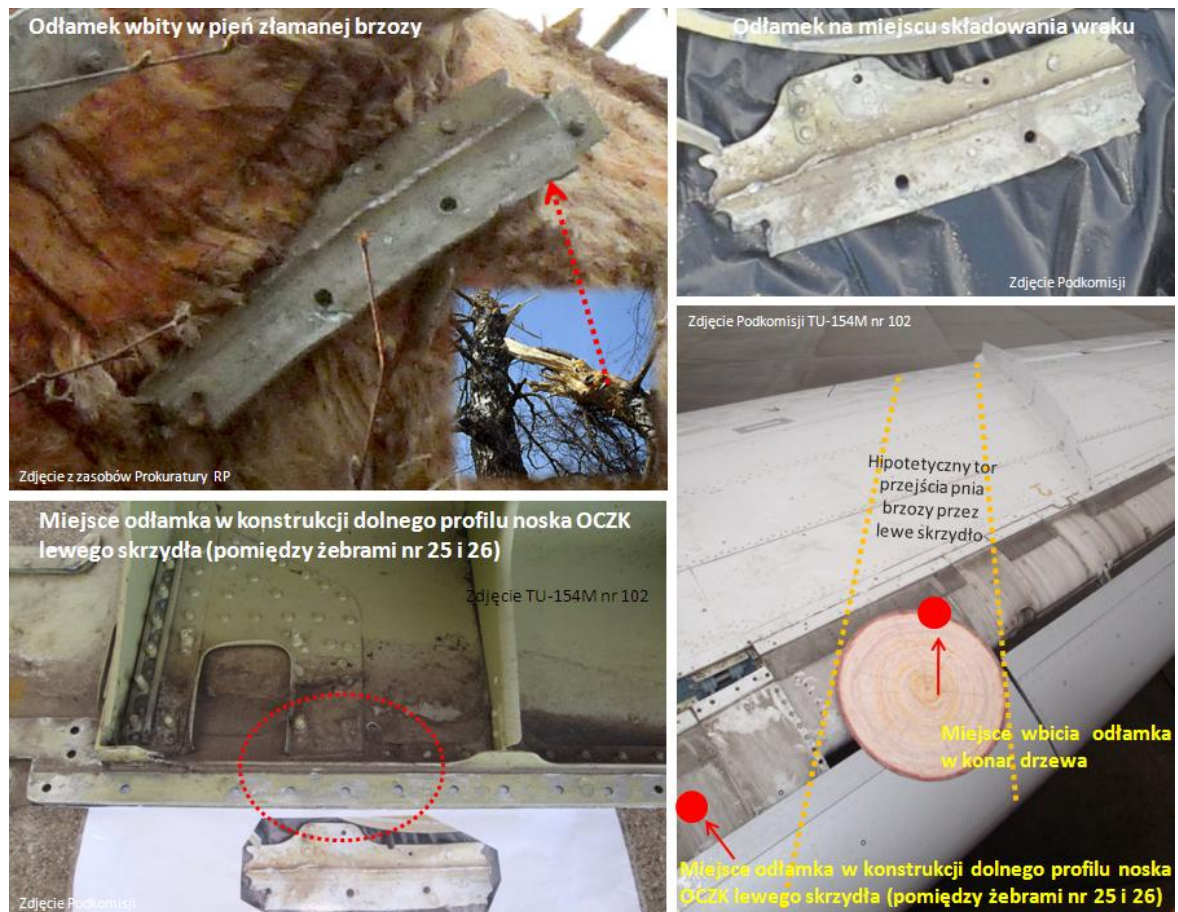
One of the elements rammed into the trunk of the so called Bodin birch does not come from the hypothetical place of contact between the wing and the birch, and was identified as an element in the construction of the plane being 70cm closer to the fuselage, than the place of contact described by the MAK and Miller reports. (Fig. 5).

Fig. 5. The place in the wing construction of the piece rammed into the so called Bodin birch tree.

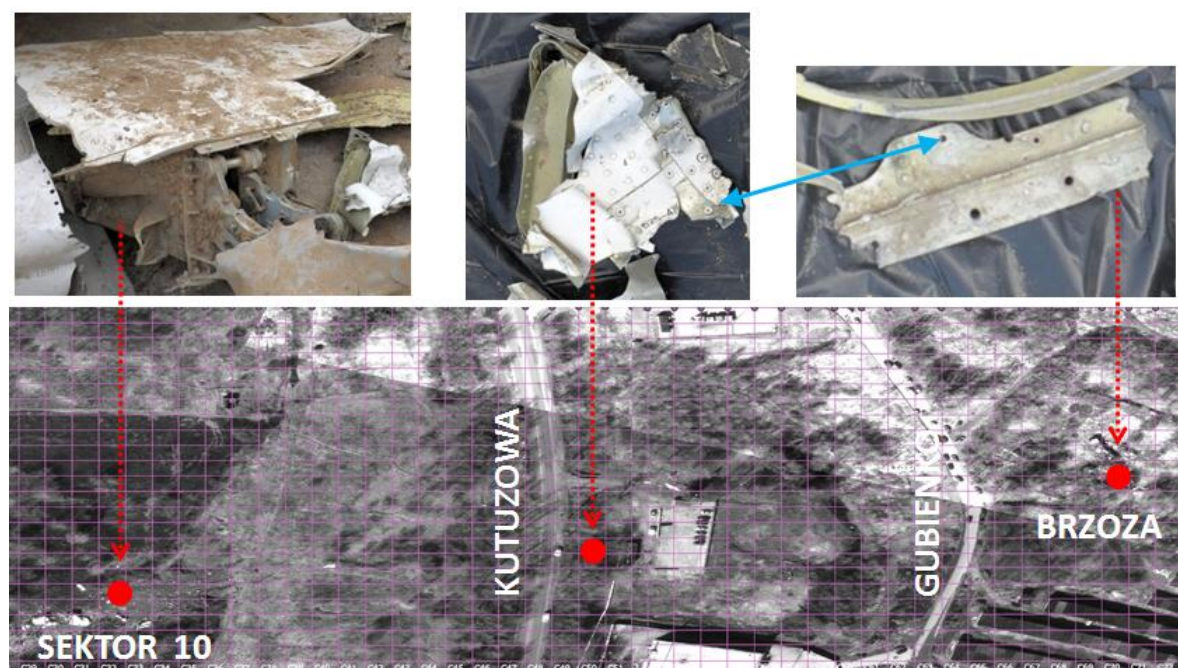
A piece of the skin of the nose, to which the piece rammed into the birch tree trunk was attached, was identified over 200m further in the direction of flight-next to the Kutuzov street. A fragment of the spar, to which this piece was attached, was identified 400m further in the direction of flight in sector 10. (Fig. 6).

Fig. 6. Position on the ground of neighboring elements in the wing construction to the debris rammed into the trunk (bb).

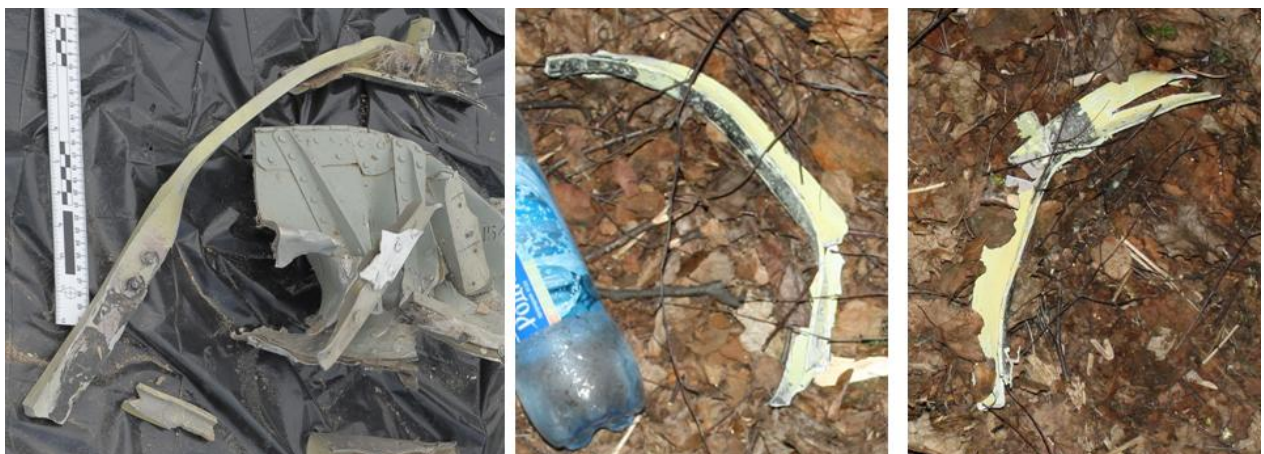
Some stringers of the left wing, which according to the MAK and Miller reports were supposed to have had contact with the Bodin birch tree, were torn away and bent outwards which shows the activity of high pressure (Fig. 8)

Fig.8. Pieces of stringers of the left wing curled outwards

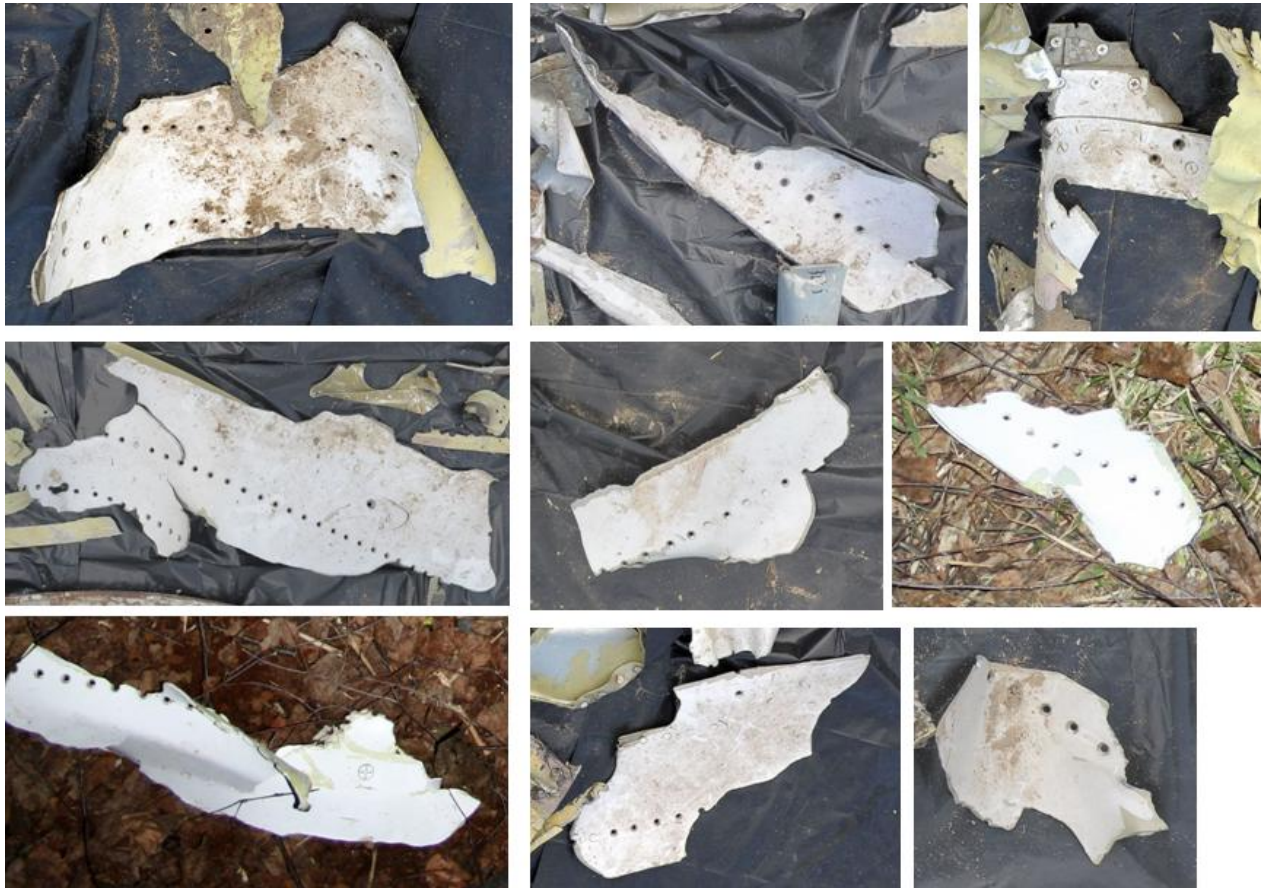
Elements of the plating of the removable part of the left wing, which according to MAK and Miller reports were supposed to have contact with (bb), were ripped out and bent outside the structure; on the surface upwards (Fig. 9), on the bottom surface downwards (Fig. 10).

Fig. 9. Pieces from the top skin curled outwards.

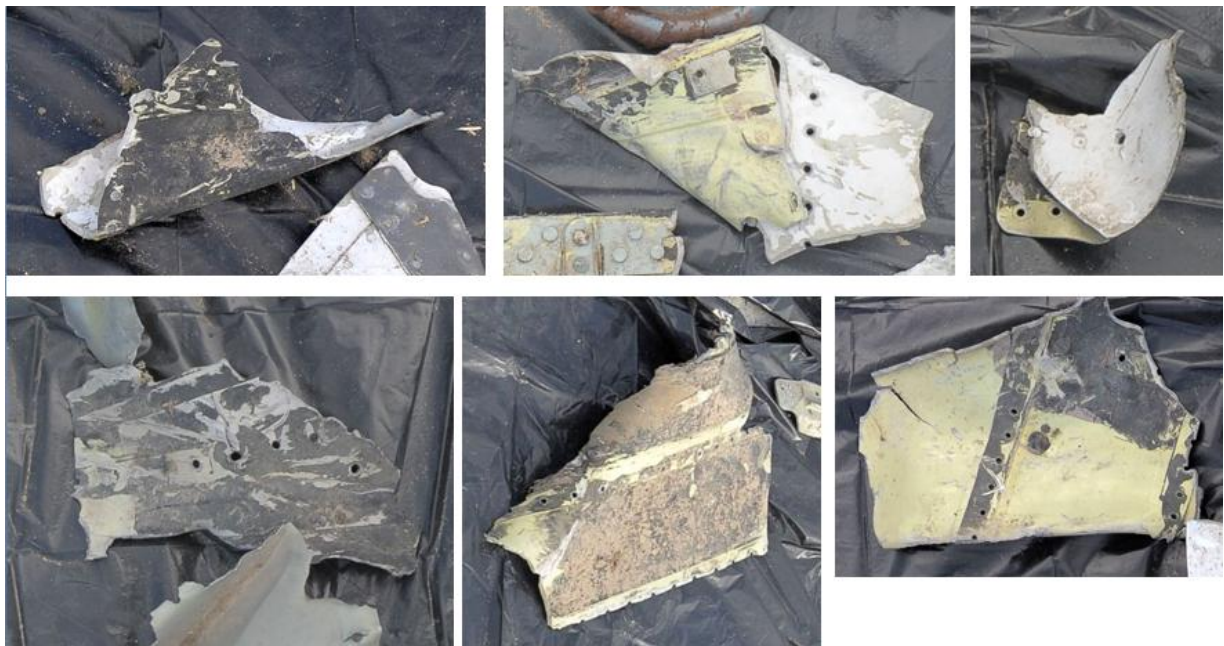
Fig. 10. Fragments of the bottom skin curled outside the structure.
