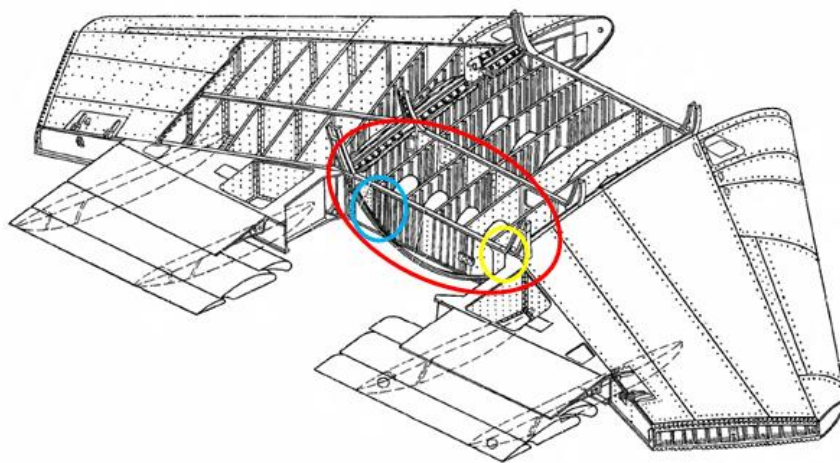
The tearing and the destruction of the fuel box could not have been a result of a hydraulic impact, caused by the impact with the ground, especially looking at the small amount of fuel and limited space. One has to consider the elements of the skin, ribs, rear spar, which were torn off, most likely due to high internal pressure. (Fig. 38 and fig. 40).

Fig. 39. Center wing box of TU-154M. Highlighted in red **fuel box no.1**.
